## **FIELD ACTIVITIES REPORT Mine Adit Entry**

**RED AND BONITA MINE SITE  
Silverton, San Juan County, Colorado**

**TDD No. 1008-01**

**January 20, 2012**

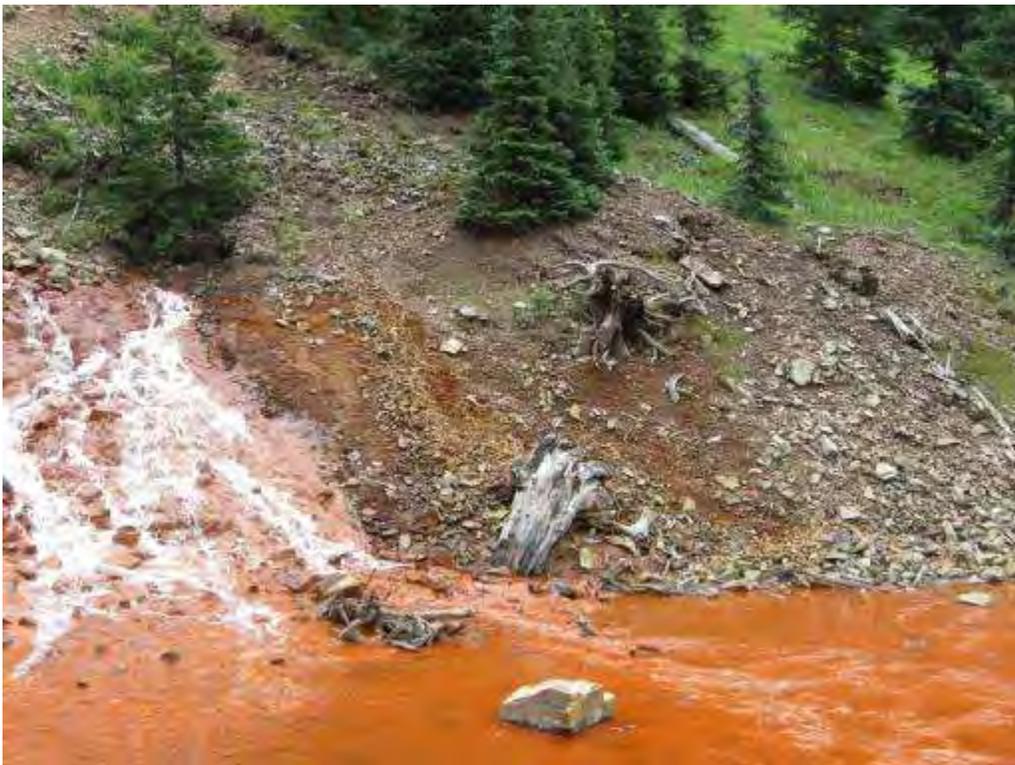
**PHOTO 12 8-24-2011**

Field conditions prior to adit entry activities. AMD flowing from mountain side at apparent adit location.

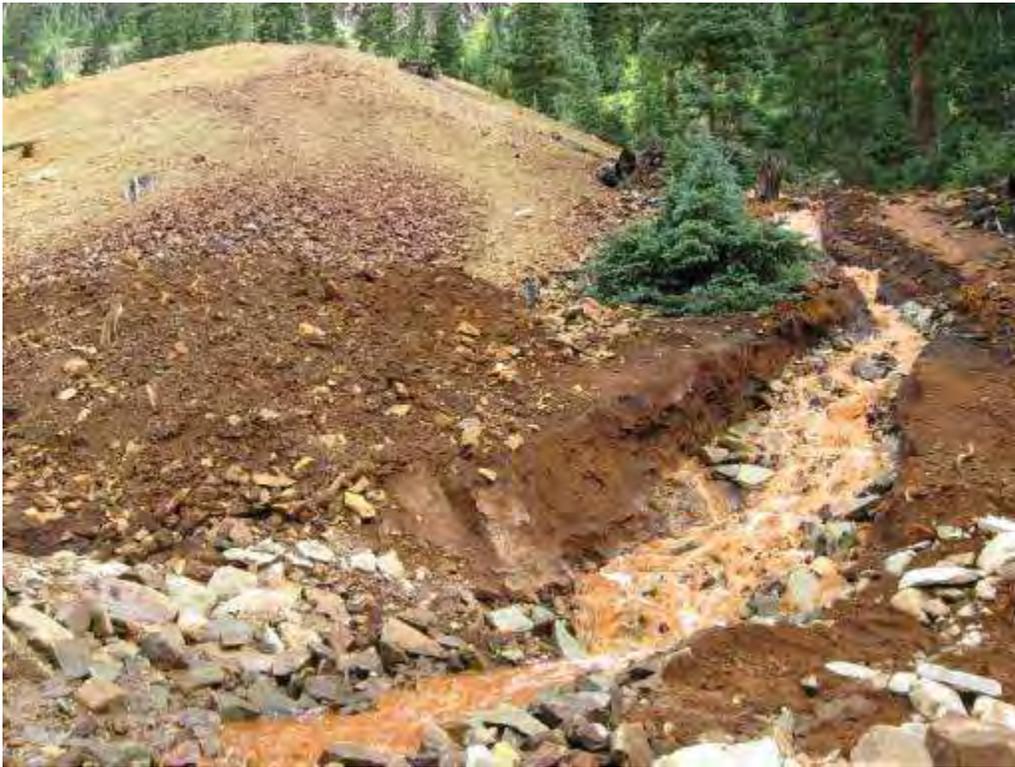
**PHOTO 13 8-29-2011**

Initial diversion flow from adit into south ditch. Red color derived from ditch sediments washing out.

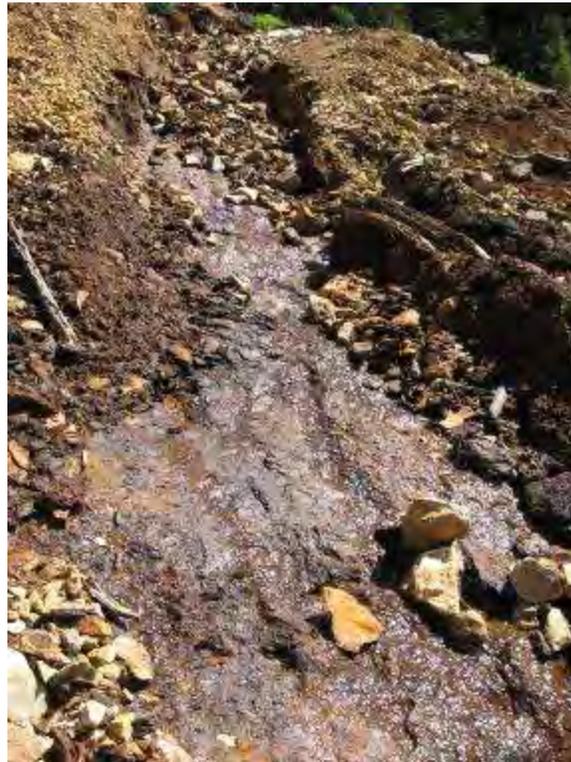
**PHOTO 14 8-30-2011**

South ditch flow temporarily diverted. Red-colored resistant ferricrete underlying thin soil and dump material.

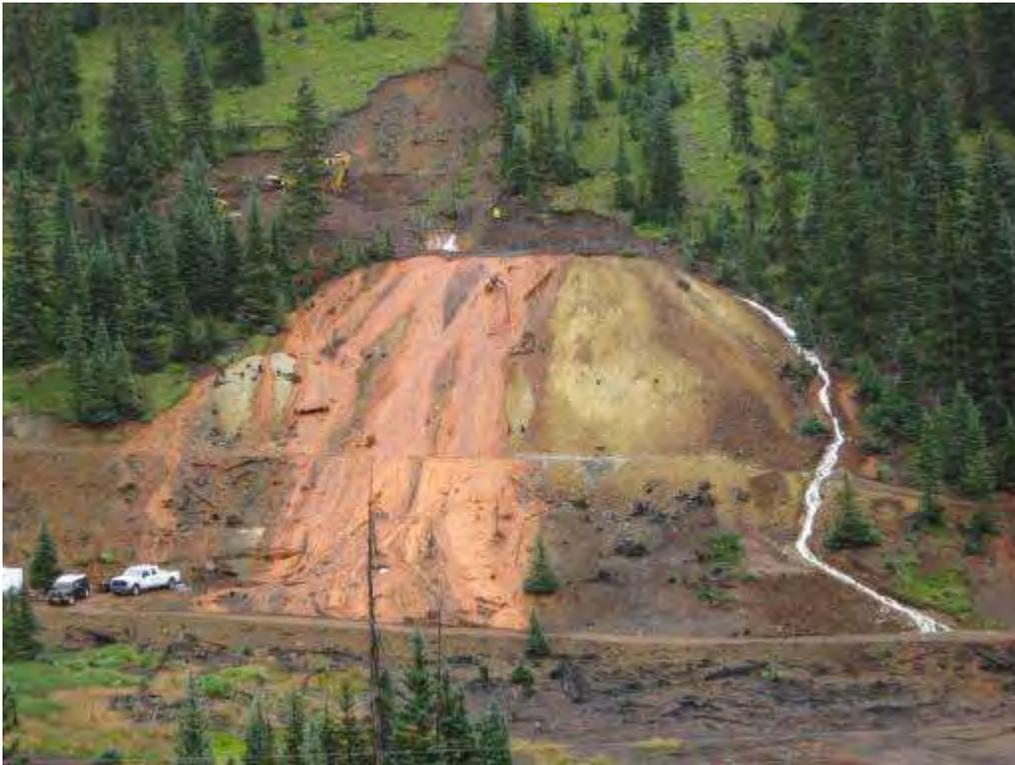
**PHOTO 19 9-6-2011**

Red and Bonita Mine. AMD cascading down portal collapse at top left of dump into the south ditch on right. Red and Bonita Mill debris in area on left side of dump above vehicles.

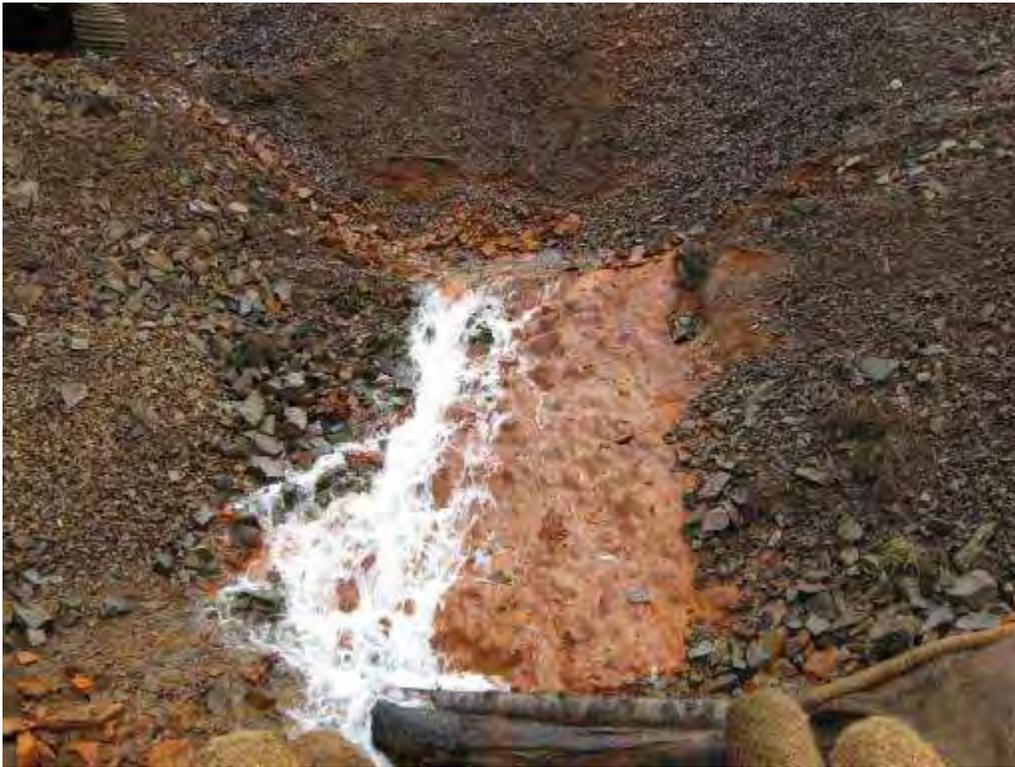
**PHOTO 25 9-11-2011**

During excavation activities, AMD effluent water was observed to flow through the collapsed material from a distinct upper horizontal limit, as determined by yellow boy staining. This upper limit line coincided with the current adit flow, and was later discovered to coincide with some of the rail spiling. Upon additional excavation it was determined that AMD effluent water was releasing from the adit at the roof elevation. The mine adit outline was eventually observed to be easily distinguished from the mountainside and was encountered within a few horizontal feet of the slope surface (Photo 30). The adit entrance was discovered to be contained within a resistant ferricrete formation of undetermined thickness and lateral extent. Apparently, because of the steep 44 percent slope, loose talus material was able to slide down-slope over an unknown number of years to collapse and fill the mine portal area.

Excavated approximately 3 feet of collapsed talus material from portal area. Note yellow boy-coated talus material and small piece of horizontal lagging at yellow boy horizon.

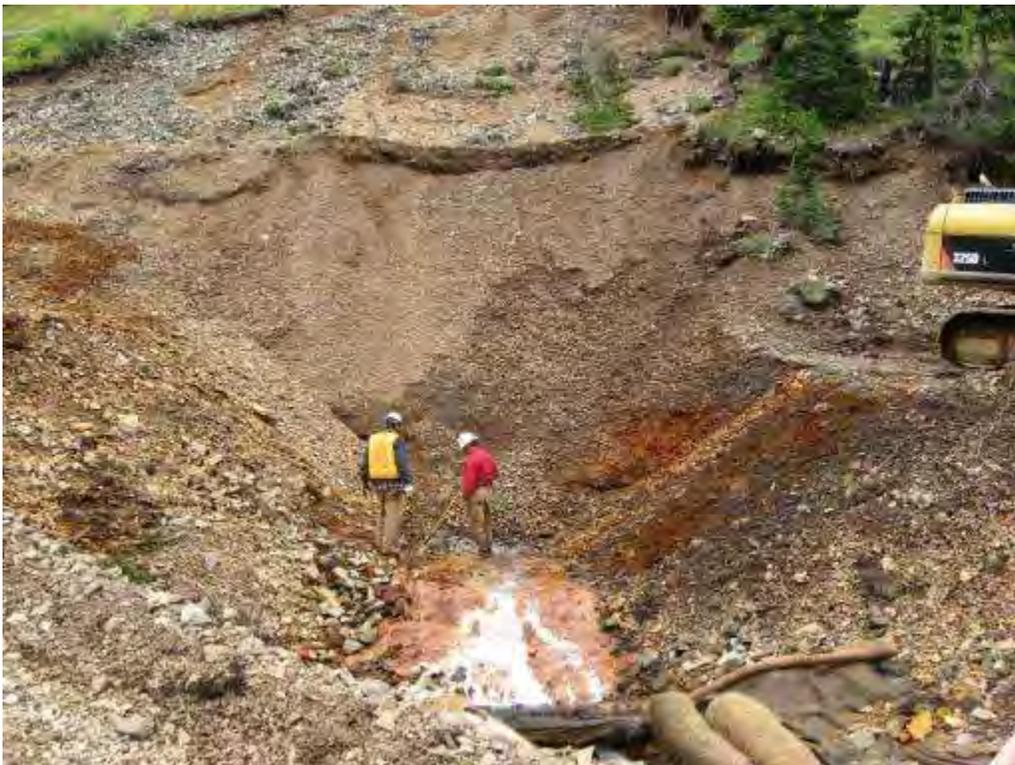
**PHOTO 28 9-13-2011**

Collapsed portal work area. Removed approximately 6 feet of talus material from in front of adit to level where workman is standing. Top of red staining at dig face indicates upper AMD flow level. Note talus sloughing due to steep slope.

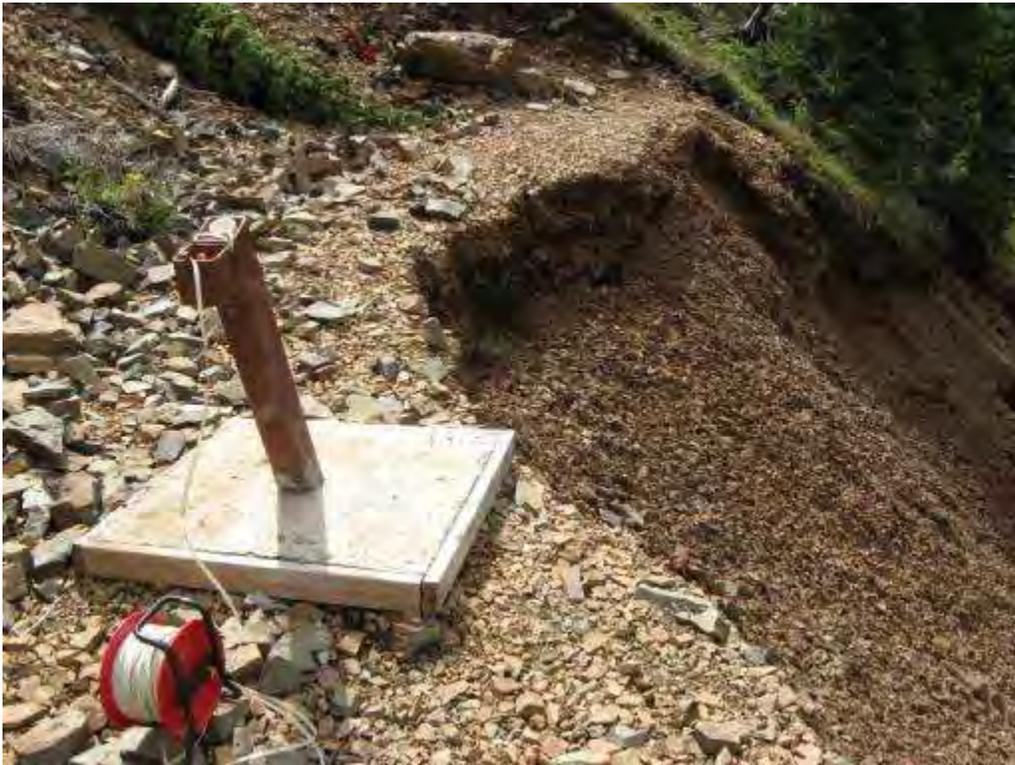
**PHOTO 29 9-13-2011**

Slope failure at bench above excavation area at collapsed portal. Note water level indicator tool in well.

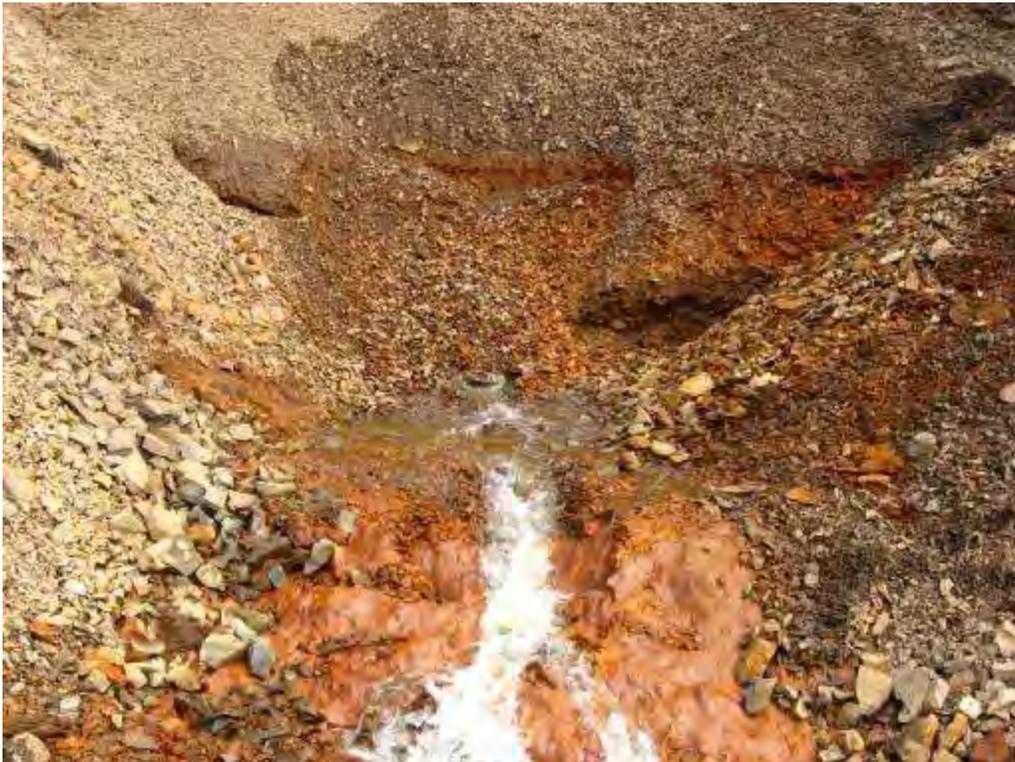
**PHOTO 30 9-13-2011**

Collapsed portal work area. Dark red ferricrete formation becoming apparent at dig face, visible above right of AMD outflow. Line of red staining in photo top indicates AMD flow level and deposition of yellow boy.

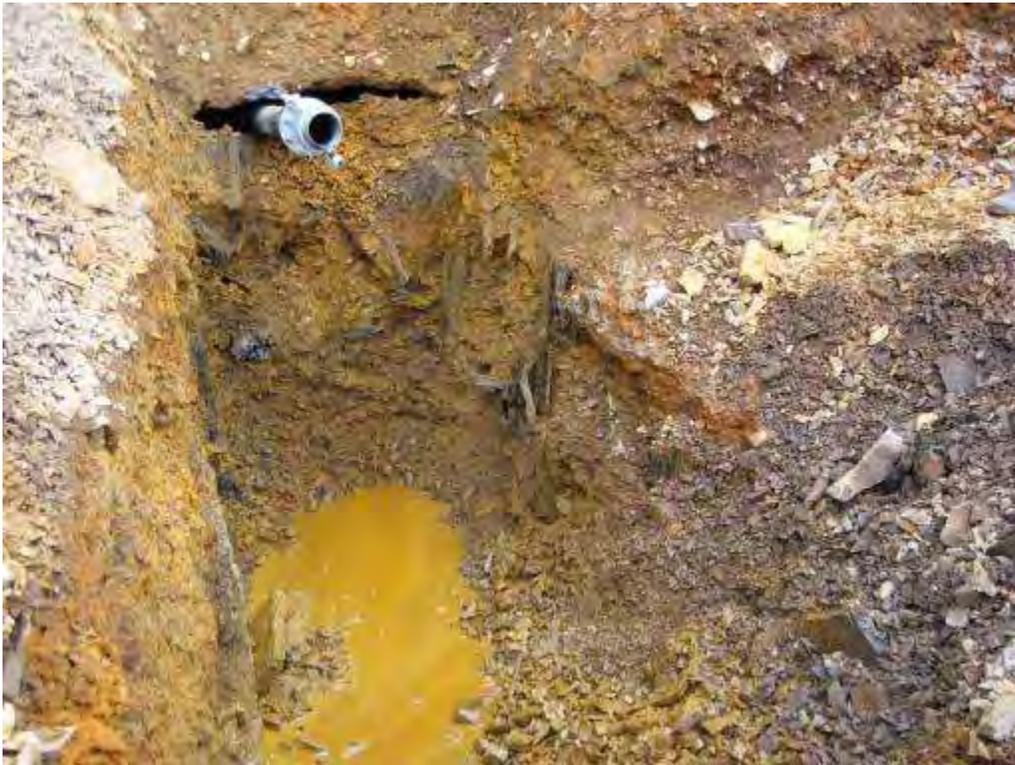
**PHOTO 37 9-27-2011**

Invert of adit on solid ferricrete formation under standing water in photo. Note wood debris. Portion of red ferricrete wall visible on right of excavation.

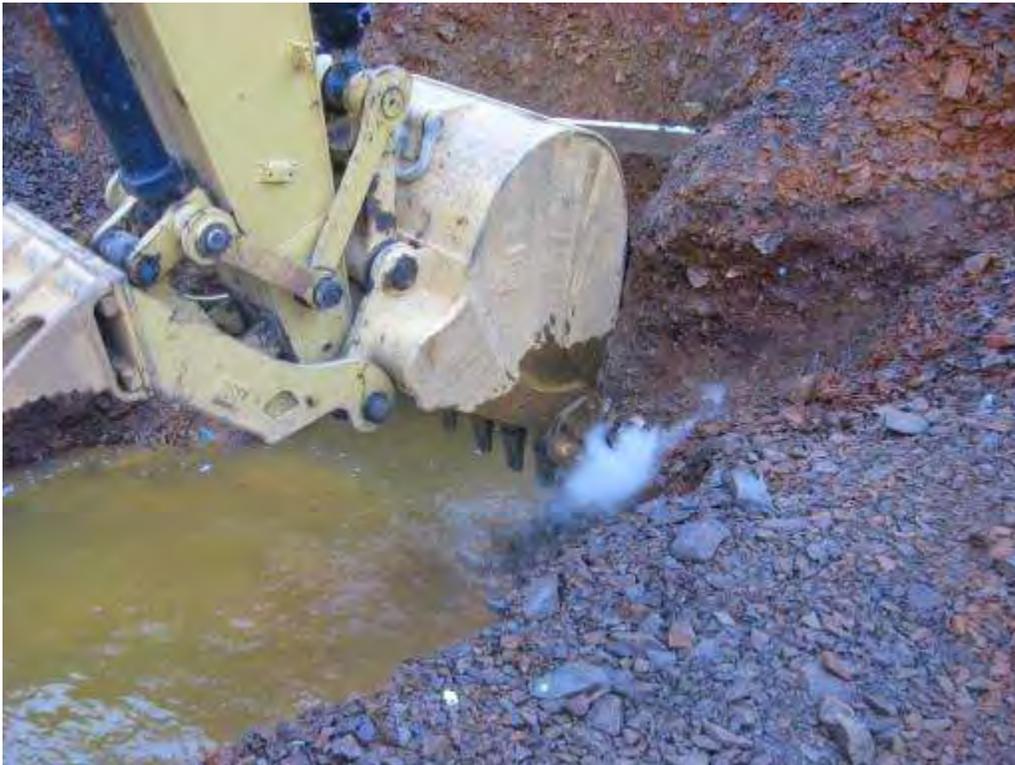
**PHOTO 41 9-30-2011**

In order to install the new corrugated galvanized metal culvert portal structure as closely to the adit opening as possible, a minor amount of ferricrete had to be broken from the outwardly sloping side walls using the excavator. The ferricrete was very hard and difficult to break from the mountainside (Photo 41). A 10-foot horizontal section of 10-foot diameter culvert pipe was placed to within approximately 3 feet of the top of the sloping ferricrete adit entrance, although the lower half of the culvert pipe fit snugly against the ferricrete rock face where it had been broken out (Photo 42). Douglas fir timber roof supports were bridged from the top of the metal culvert to the ferricrete rock face and covered with loose talus material. A wood timber set was also placed under the roof support at the ferricrete rock face for added support (Photo 43). An additional 5-foot section of galvanized metal culvert pipe was also spliced to the original 10-foot section for a final portal length of 15 feet, leaving sufficient area to access the remaining dump pad. The portal structure rests on a ferricrete floor and, therefore, could not be lowered.

Excavator having difficulty breaking well-cemented ferricrete rock from portal face to accommodate new portal structure.

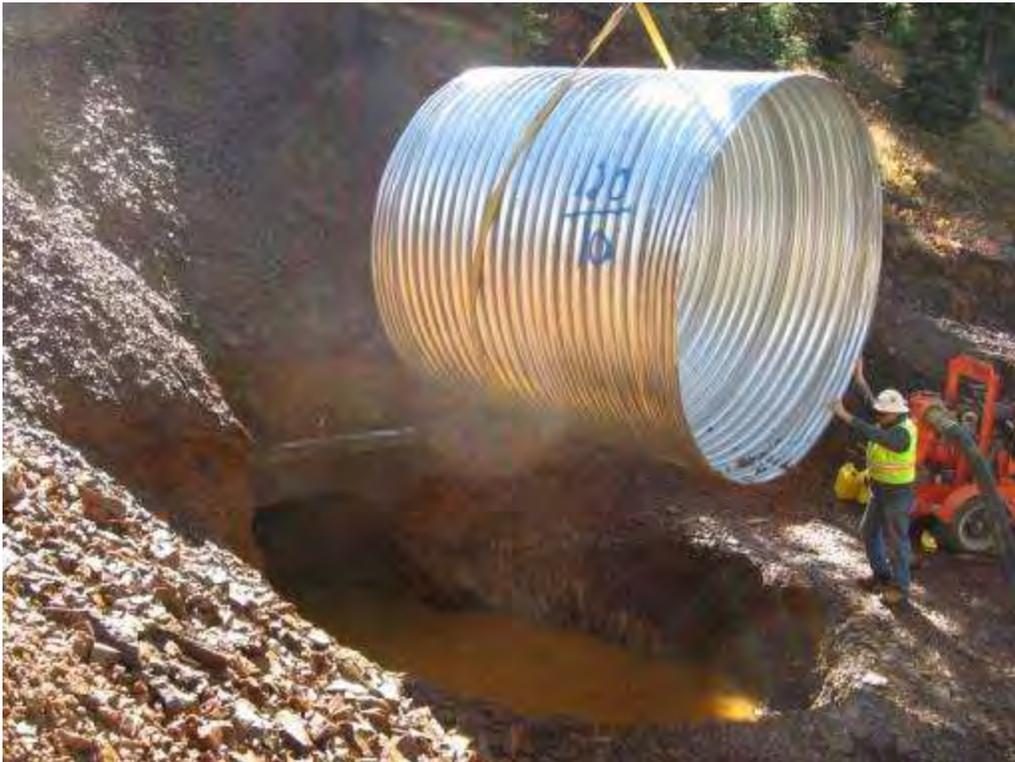
**PHOTO 42 9-30-2011**

Placing portion of new portal structure. Ten-foot diameter galvanized steel culvert pipe.

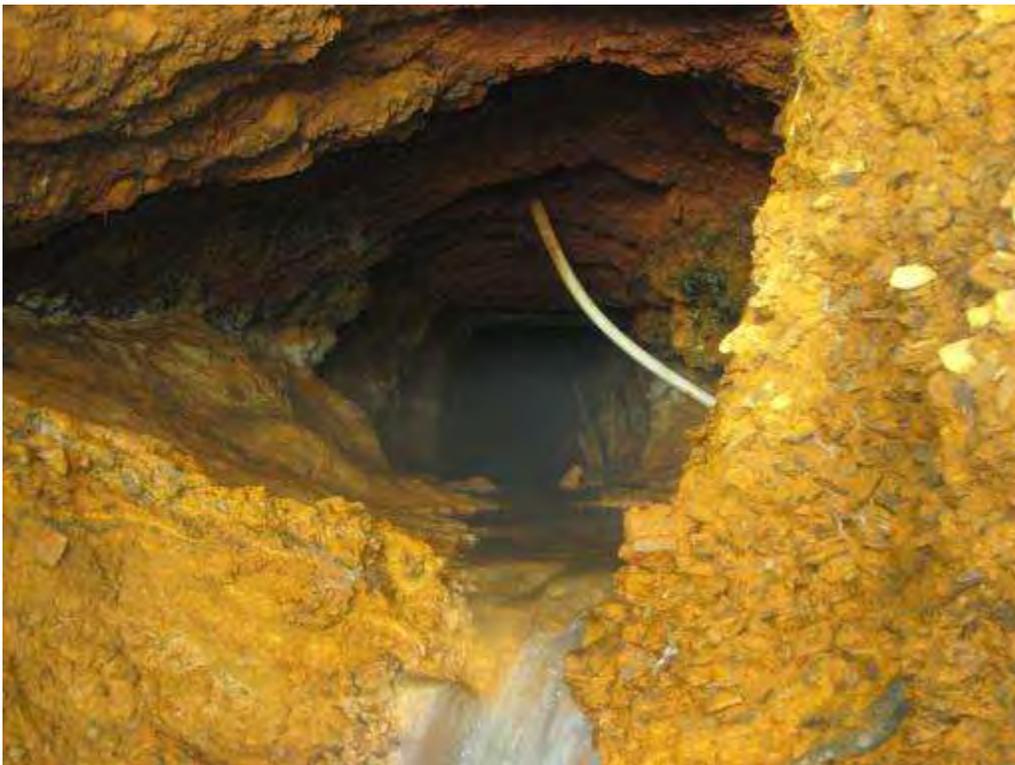
**PHOTO 44 10-11-2011**  
View into adit from portal. Sediment material on floor in photo foreground is 2 feet thick, approximately 4 feet of open space to adit back. AMD water draining down center. PVC monitoring well pipe is visible in adit. Note timber set visible behind PVC well.

the adit floor at the entrance, and the fines are suspected to become thinner with further entry into the adit, as the adit floor is declined to promote outward water flow. Approximately 4 feet of void space was measured from the fines on the floor to the adit roof. A timber set is observed an estimated 80 feet inby, as well as remnant material including a wood wedge still intact on the right rib near the entrance (Photo 44).

Future entry and inspection for water resources and rock structure relative to potential bulkhead placement will require ventilation and adit rehabilitation with placement/replacement of timber sets and clean-out of residual precipitation solids from the adit floor. Because the adit maintains a perennial flow of AMD, some water handling inside the adit would also be required. The base area around the mine portal will require modification to allow for reasonable access into the mine by personnel and equipment; e.g., the AMD flow will likely need to be placed into a buried outflow pipe so that a level working surface outside of the portal may be constructed. Well RB-1, which was installed into the mine adit in 2010 from a bench above the mine portal, should be abandoned as it is no longer useful. Pending work on the mine adit rehabilitation, site restoration work will be performed. As the site is located at an elevation of 11,000 feet, it receives ample snowpack and is accessible typically during July through September; therefore, work seasons are short.

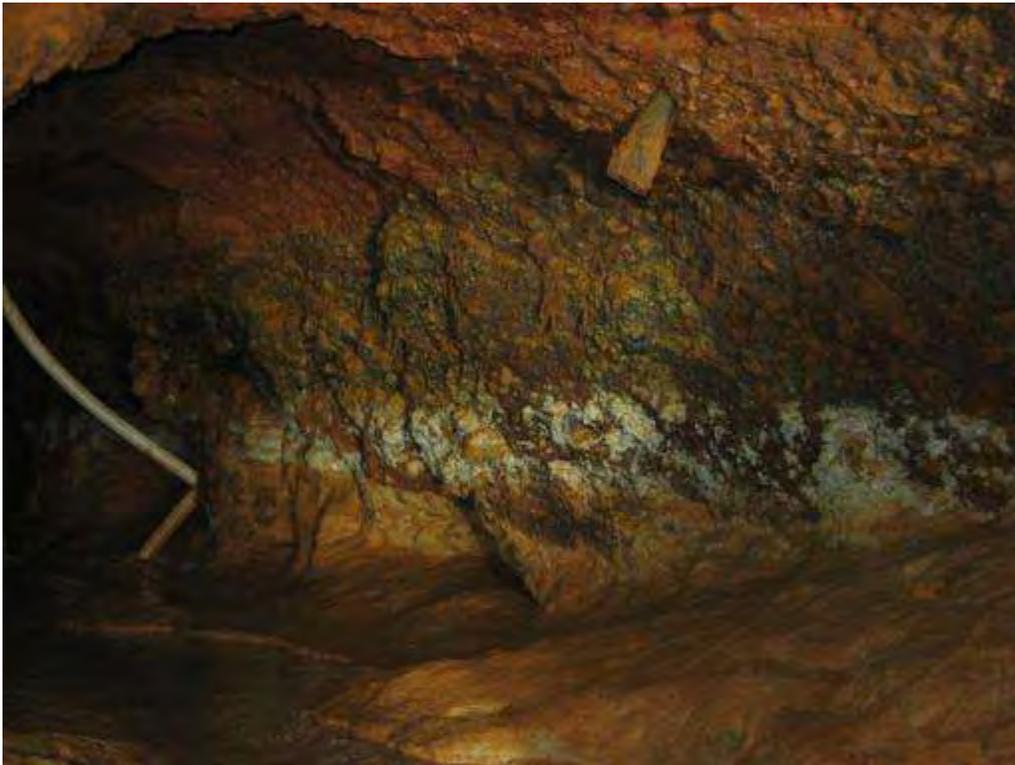
**PHOTO 45 10-12-2011**

Ferricrete walls inside the adit are stained red, orange, and white (Photo 45). The various colors are likely due to differing metals (likely predominantly iron and aluminum) dropping out of solution onto the rock walls. Apparent integrity of the adit seems to be very good as little collapse material could be discerned on the adit floor, and the adit walls and roof do not seem to be malformed from excessive caving.

Right rib of adit near portal showing various stained horizons on ferricrete formation. Orange-colored yellow boy fines on adit floor, light grey (aluminum hydroxide?) material on wall above yellow boy material, dark red iron oxide staining on back of adit. PVC well pipe in photo left, wood remnant wedge still intact in adit back.

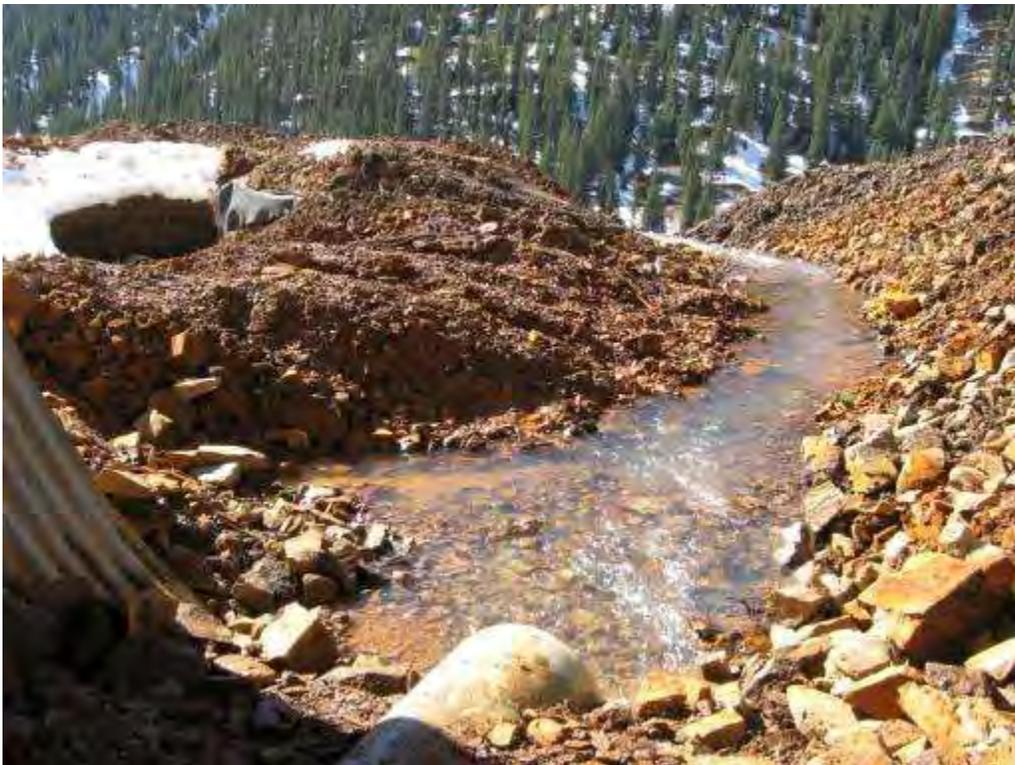
**PHOTO 46 10-13-2011**

AMD effluent from the adit via PVC pipe at the base of the portal structure. Water is directed to the flow location over the dump face that was in place prior to site activities.
