## **FIELD ACTIVITIES REPORT Mine Adit Entry**

**RED AND BONITA MINE SITE  
Silverton, San Juan County, Colorado**

**TDD No. 1008-01**

**January 20, 2012**

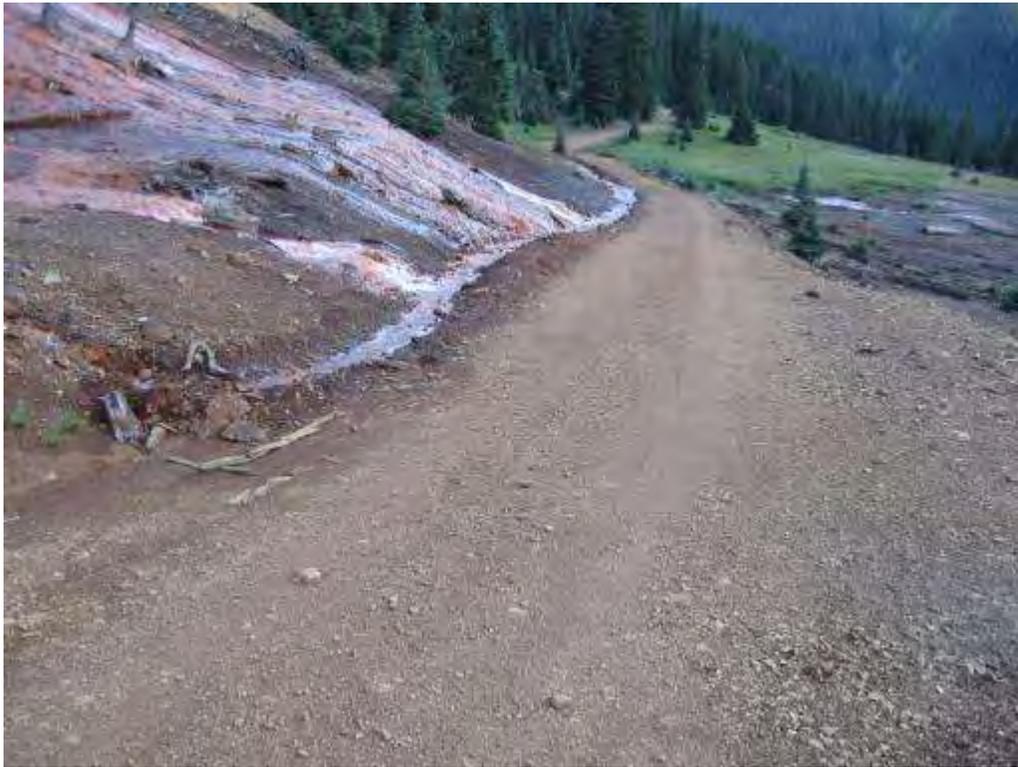
**PHOTO 1 8-23-2011**

Field conditions prior to adit entry activities. South view along CR 53. Toe of dump on left. See also Photo 2.

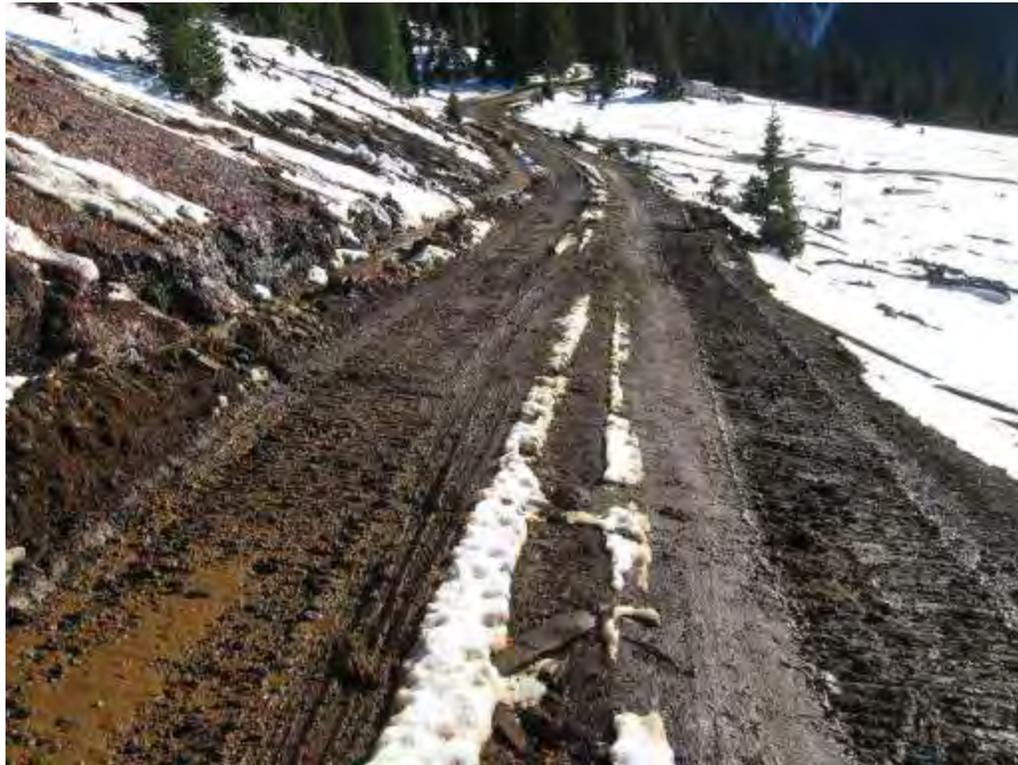
**PHOTO 2 10-13-2011**

Field conditions after adit entry. View south along CR53, toe of dump on left. See also Photo 1.

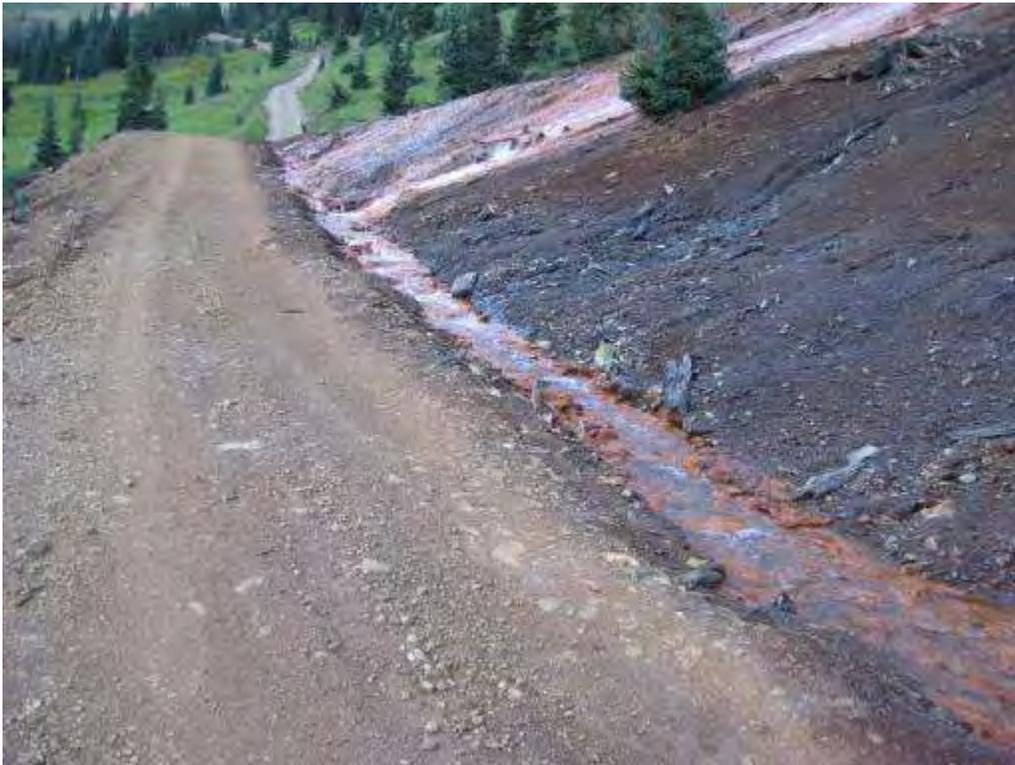
**PHOTO 3 8-23-2011**

Field conditions prior to adit entry activities. View northward on CR53, toe of dump on right. See also Photo 4.

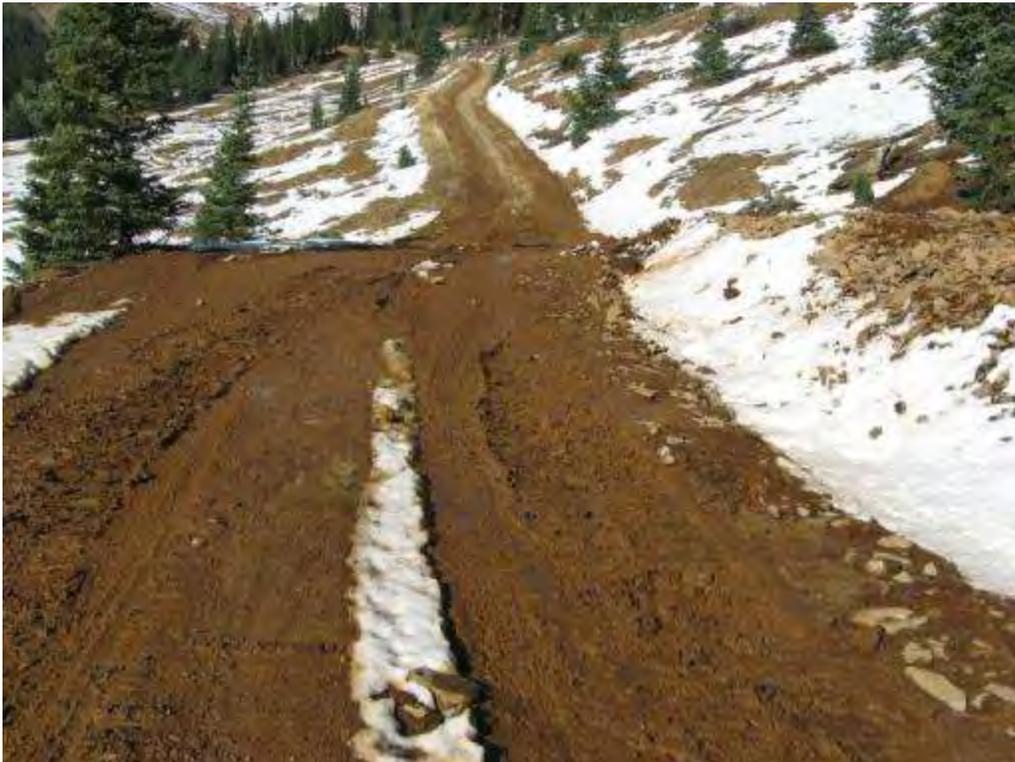
**PHOTO 4 10-13-2011**

Field conditions after adit entry. View north on CR53, manifold filter bag area on right. See also Photo 3.

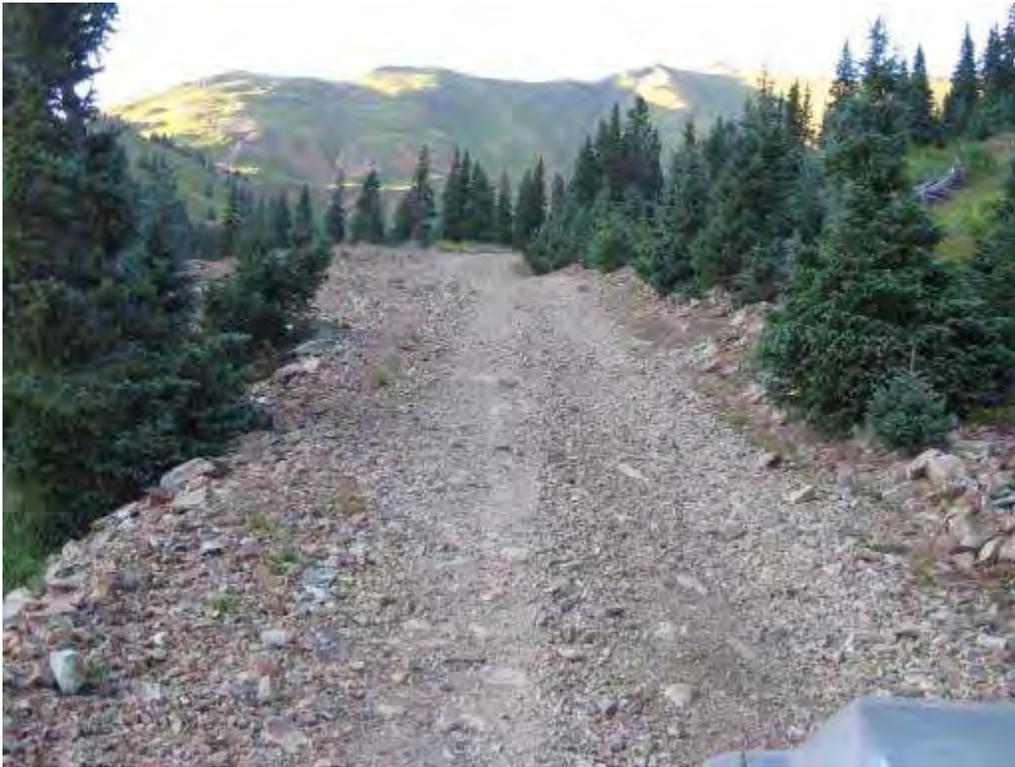
**PHOTO 5 8-23-2011**

Field conditions prior to adit entry activities. Northward view along CR53, north of mine site. See also Photo 6.

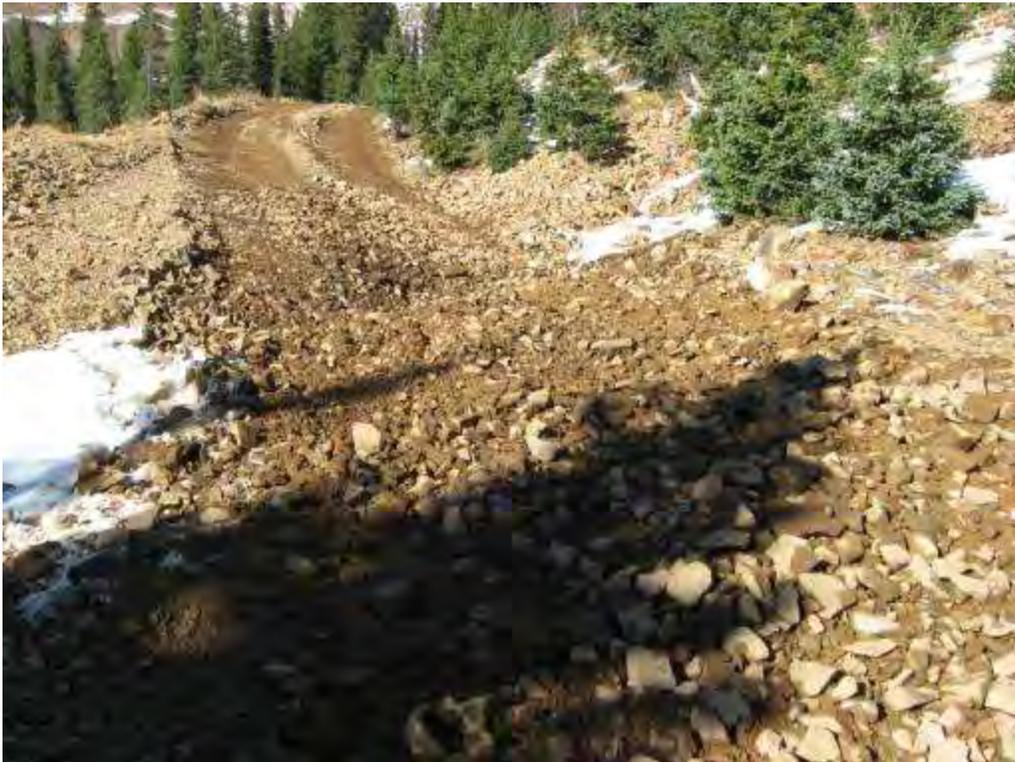
**PHOTO 6 10-13-2011**

Field conditions after adit entry. Water bar on CR53, north of mine site. North access road on level behind two trees on right. See also Photo 5.

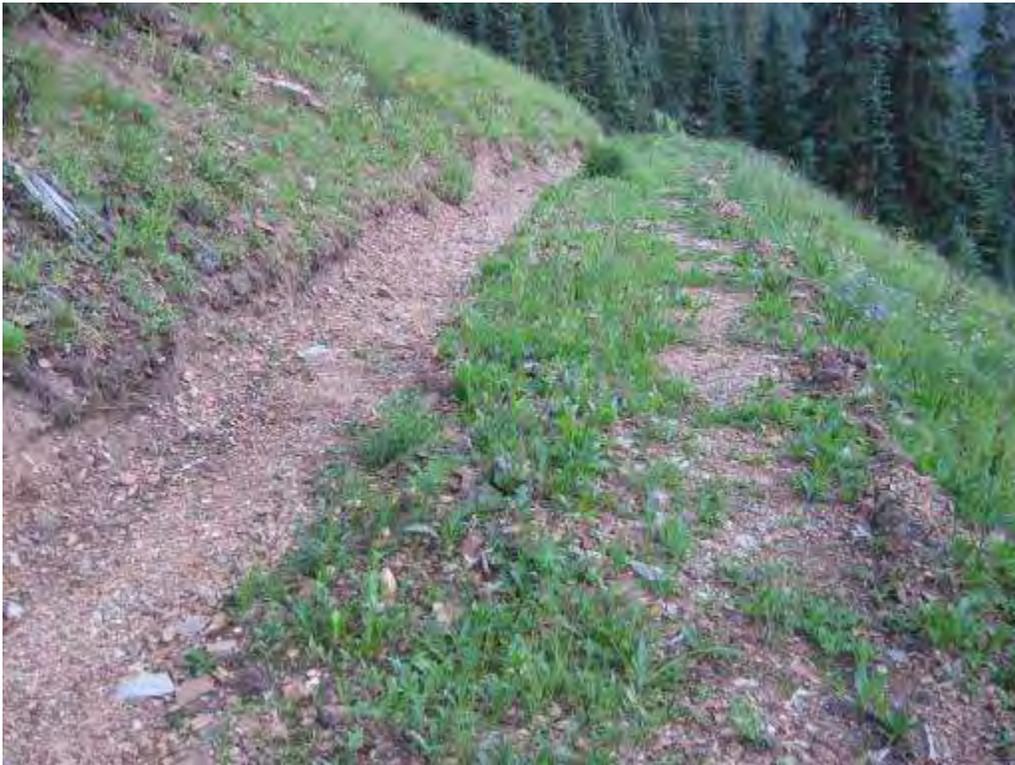
**PHOTO 7 8-23-2011**

Field conditions prior to adit entry activities. Southward view on north access road, south of gate. See also Photo 8.

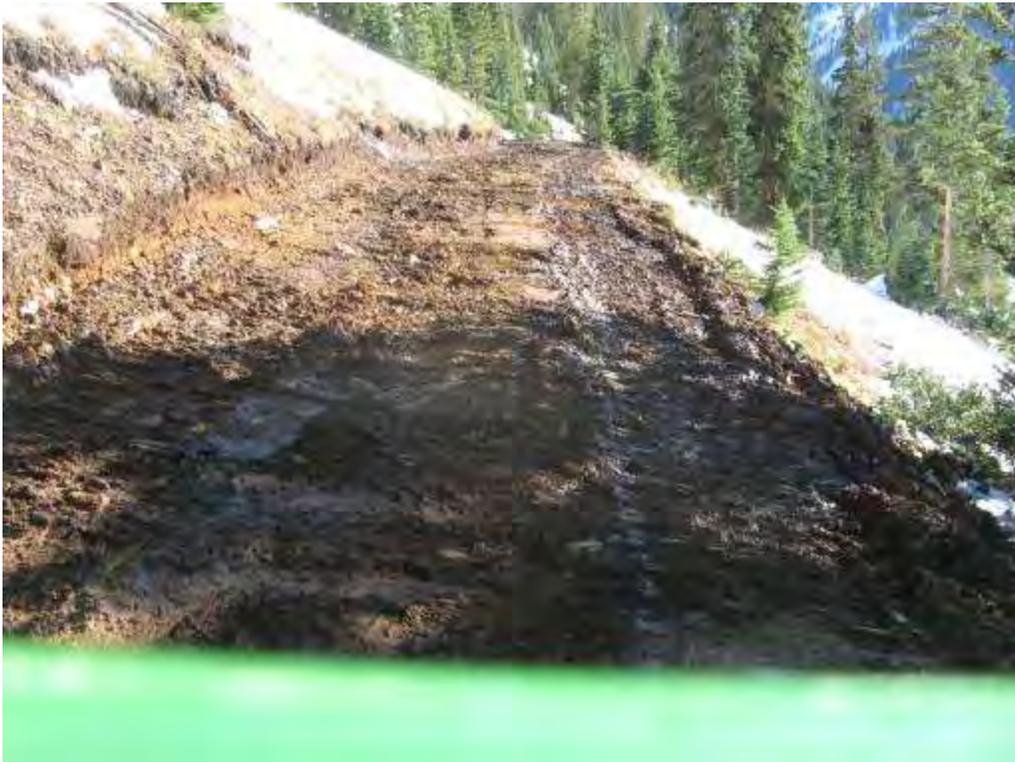
**PHOTO 8 10-13-2011**

Field conditions after adit entry. Southward view on north access road, south of gate. See also Photo 7.

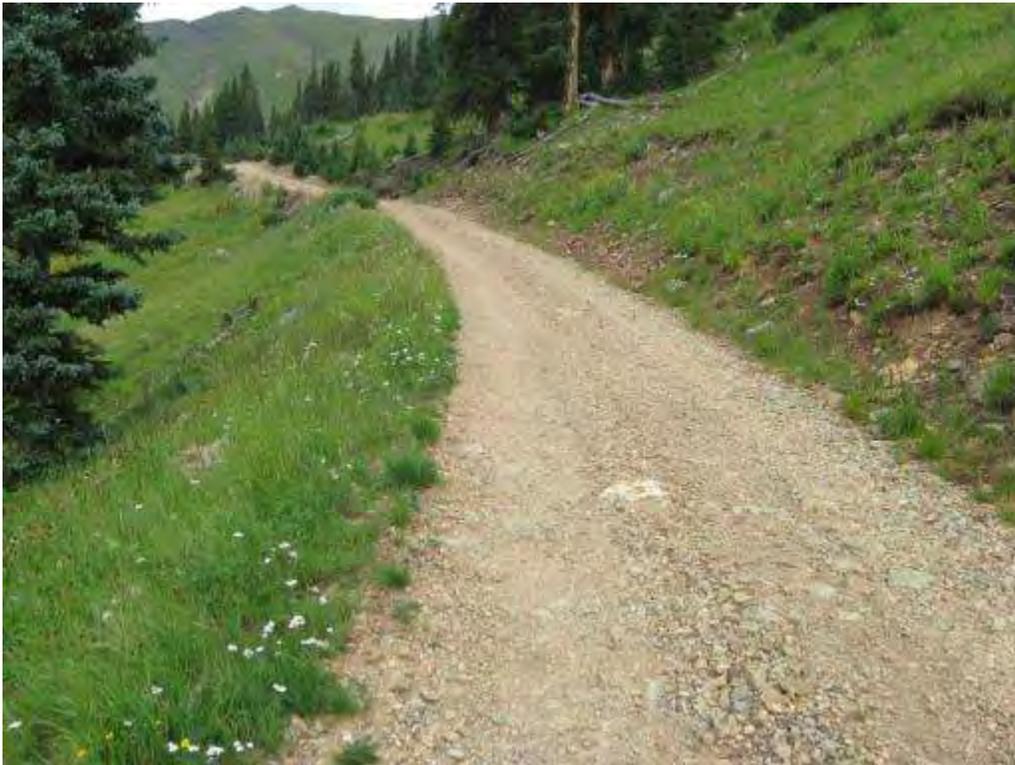
**PHOTO 9 8-24-2011**

Field conditions prior to adit entry activities. CR53 north of the mine, below the north access road intersection. See also Photo 10.

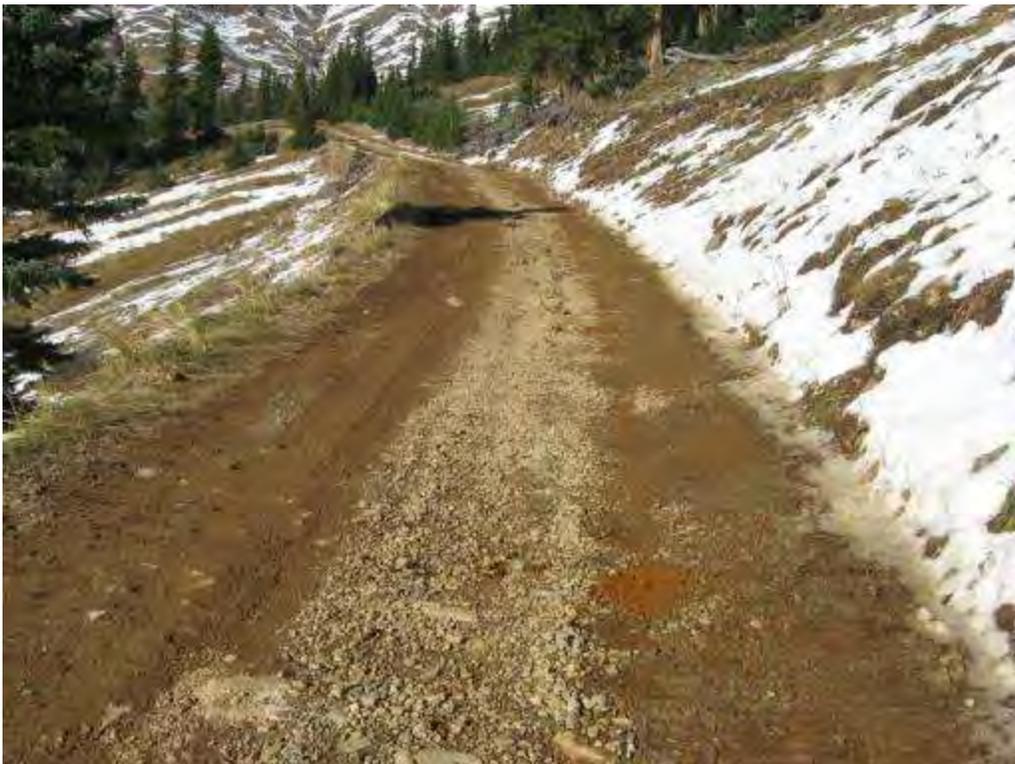
**PHOTO 10 10-13-2011**

Field conditions after adit entry. CR53 north of the mine, below the north access road intersection. See also Photo 9.

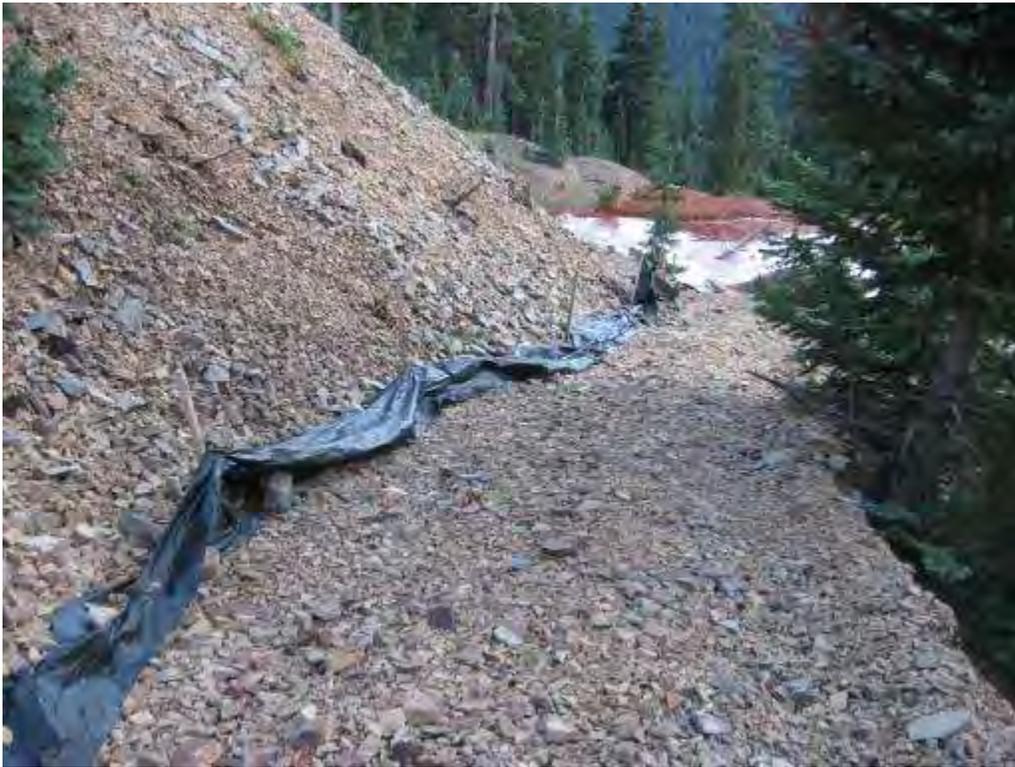
**PHOTO 11 8-23-2011**

Field conditions prior to adit entry activities. Top of mine dump visible at end of road.

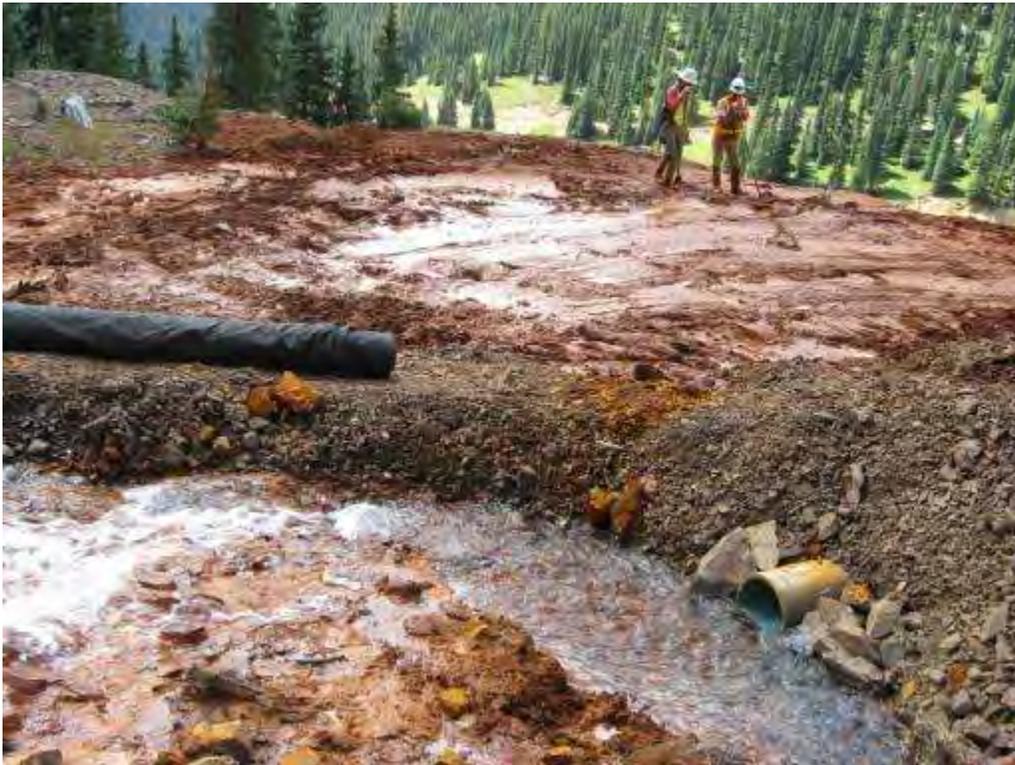
**PHOTO 15 8-30-2011**

Decanting water from yellow boy solids on dump surface. Temporary underflow pipe diverting adit water to north side of dump.

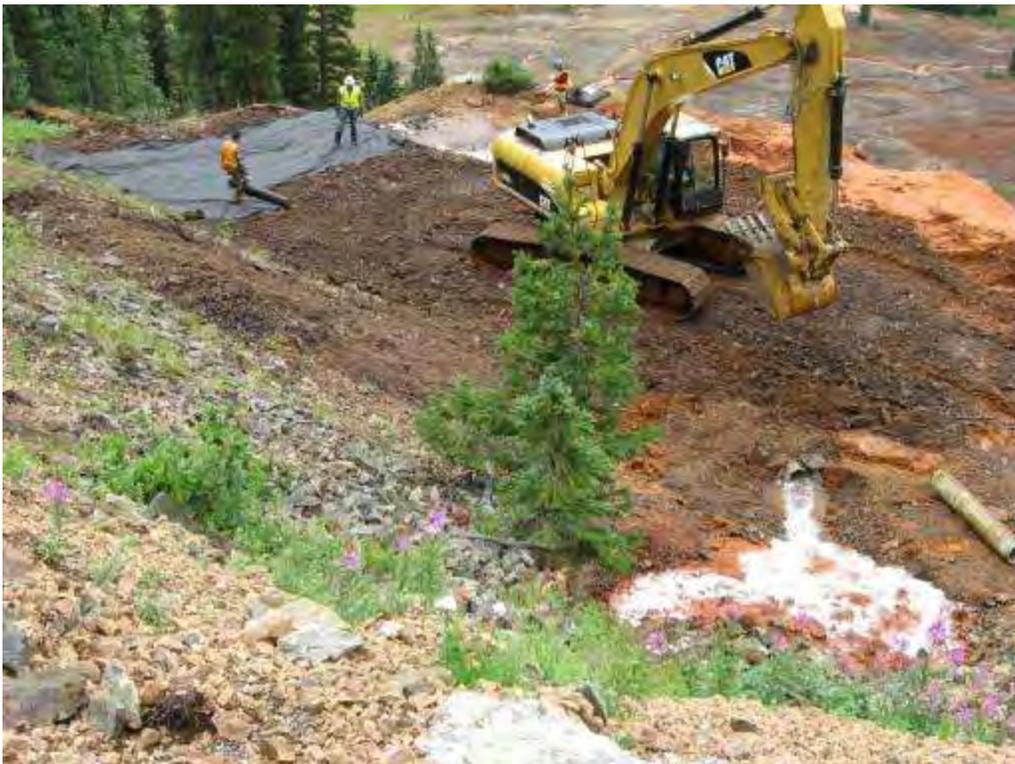
**PHOTO 16 8-31-2011**

Talus material placed over geotextile fabric that was placed over base talus material on dump surface. AMD discharge from collapsed portal in lower right, under-piped to south ditch. See also Photo 17.

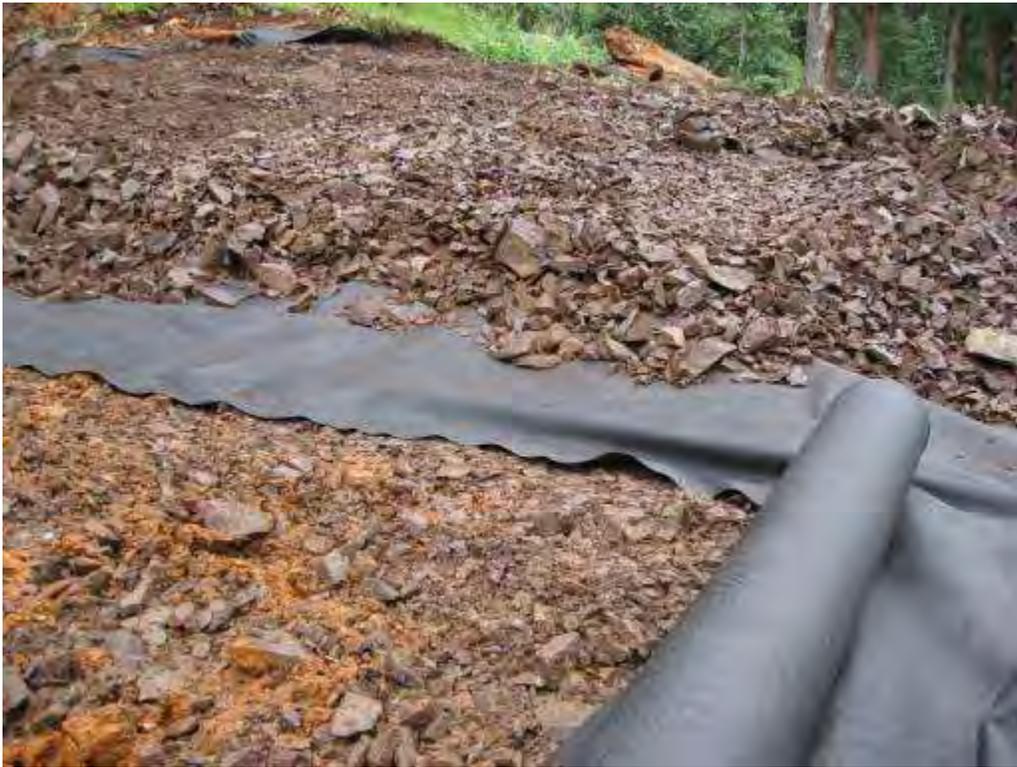
**PHOTO 17 8-31-2011**  
Geotextile fabric placed between layers of talus material on mine dump.

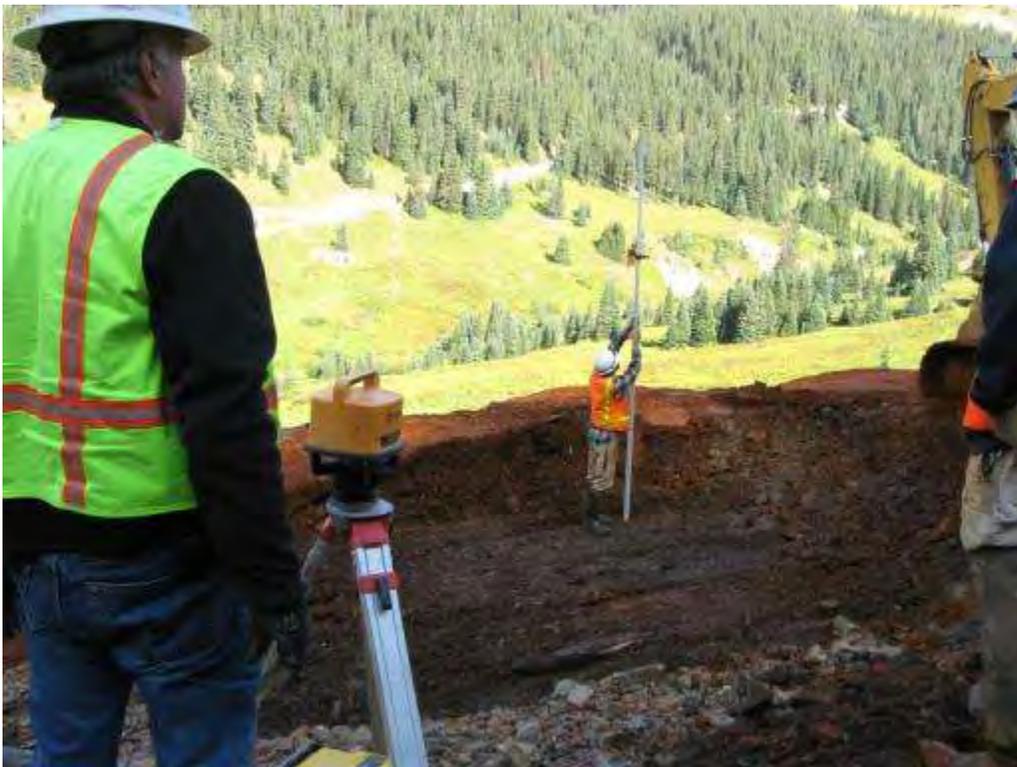
**PHOTO 18 8-31-2011**  
Constructing pad for filter bag on dump surface.

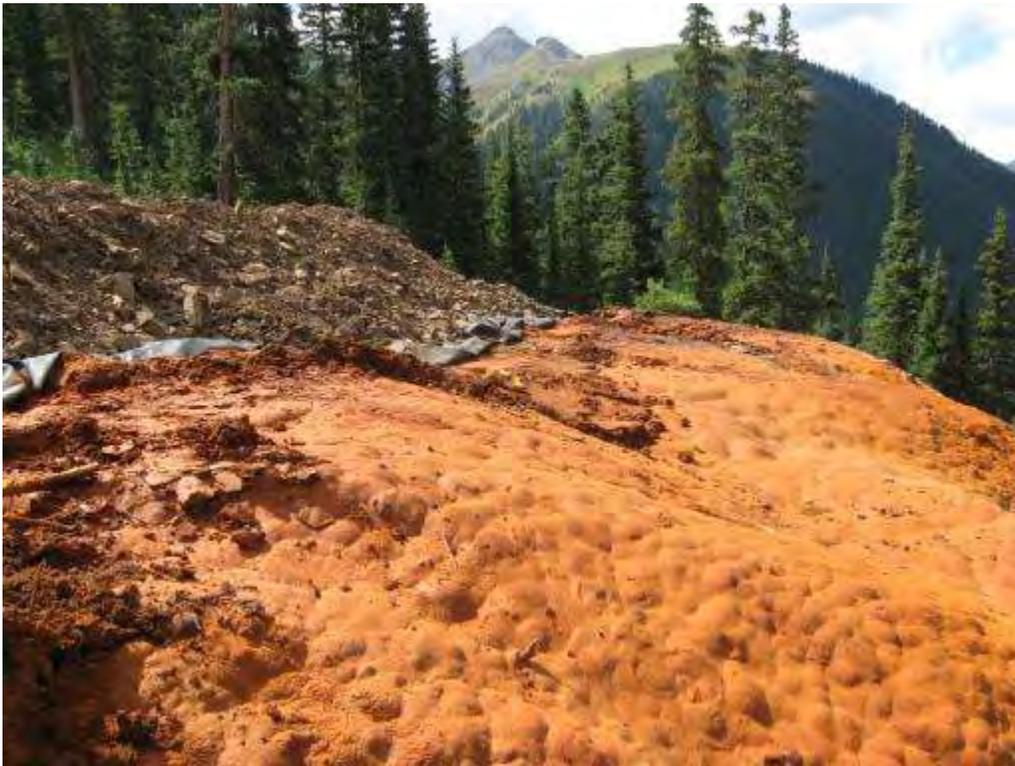
**PHOTO 20 9-8-2011**

Toe of prepared dump surface at head of dump face. Note geotextile fabric liner exposed under talus, and armored yellow boy surface on dump face.

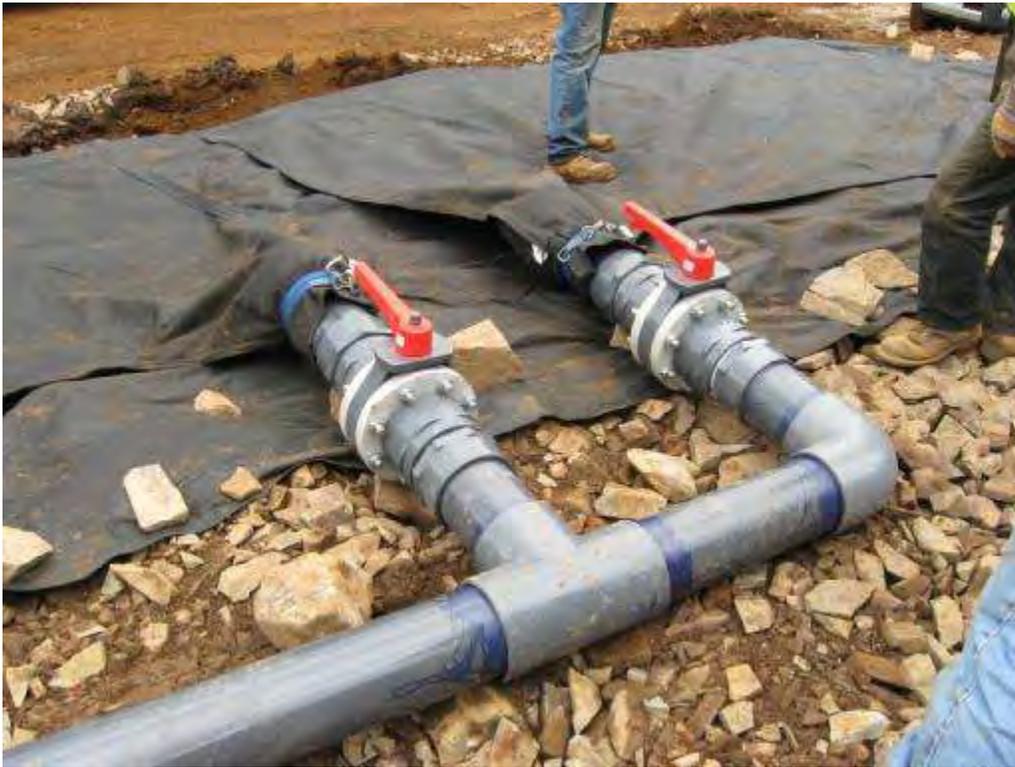
**PHOTO 21 9-10-2011**  
Valve and filter bag manifold apparatus. Unused bags.

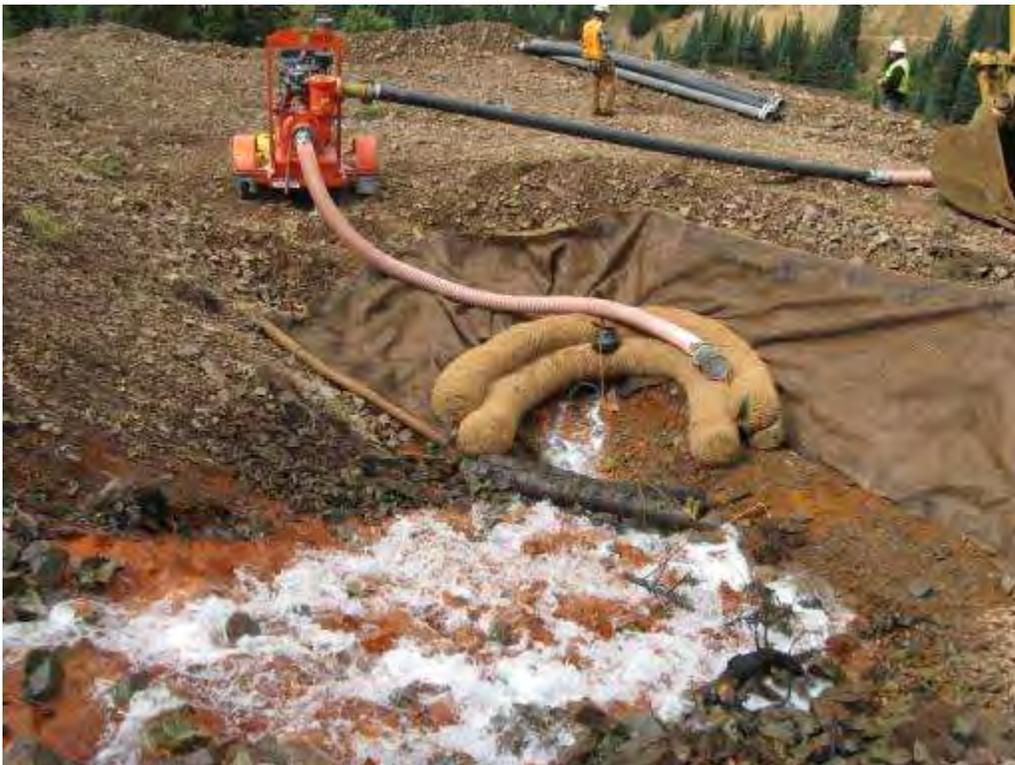
**PHOTO 22 9-10-2011**  
Koir-Logs®, filter barrier, and pump at sump below the adit outflow. Twelve-inch PVC pipe under Koir-Logs® directs water to south ditch when not being pumped to manifolded filter bag apparatus at toe of dump. Pipe can be plugged with stopper, stored on Koir-Log® in photo center.

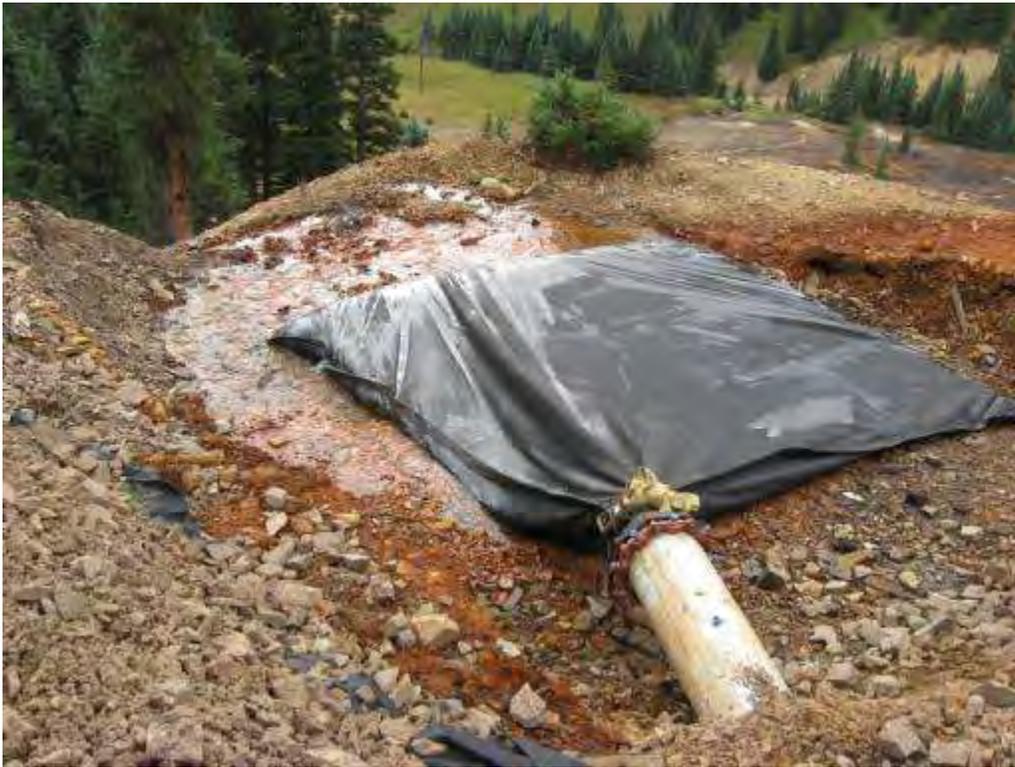
**PHOTO 23 9-10-2011**  
Geotextile filter bag at diverted adit AMD outflow. Flowing into south ditch.

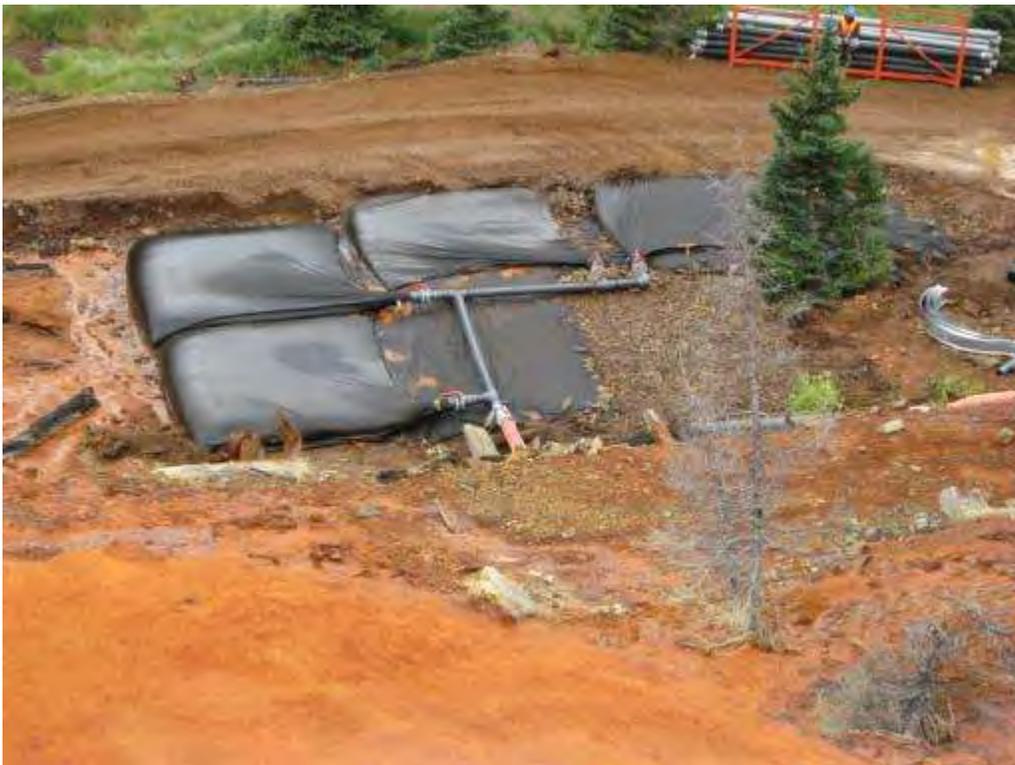
- 2) During all active excavation activities at the collapsed mine portal, AMD effluent was pumped from the sump to a series of filter bags located at the toe of the dump (Photo 24). Flocculent was added to this flow to avoid plugging the filter fabric and to aid in dropping out solids inside the filter bag prior to releasing back into the road ditch system. Additionally, a filter bag was placed within the road ditch system at the outflow end of the culvert pipe located under CR53 before passing onto Cement Creek.

**PHOTO 24 9-11-2011**  
Geotextile fabric filter bags filtering AMD water at location below working surface at adit level. Flow releasing into road ditch system.

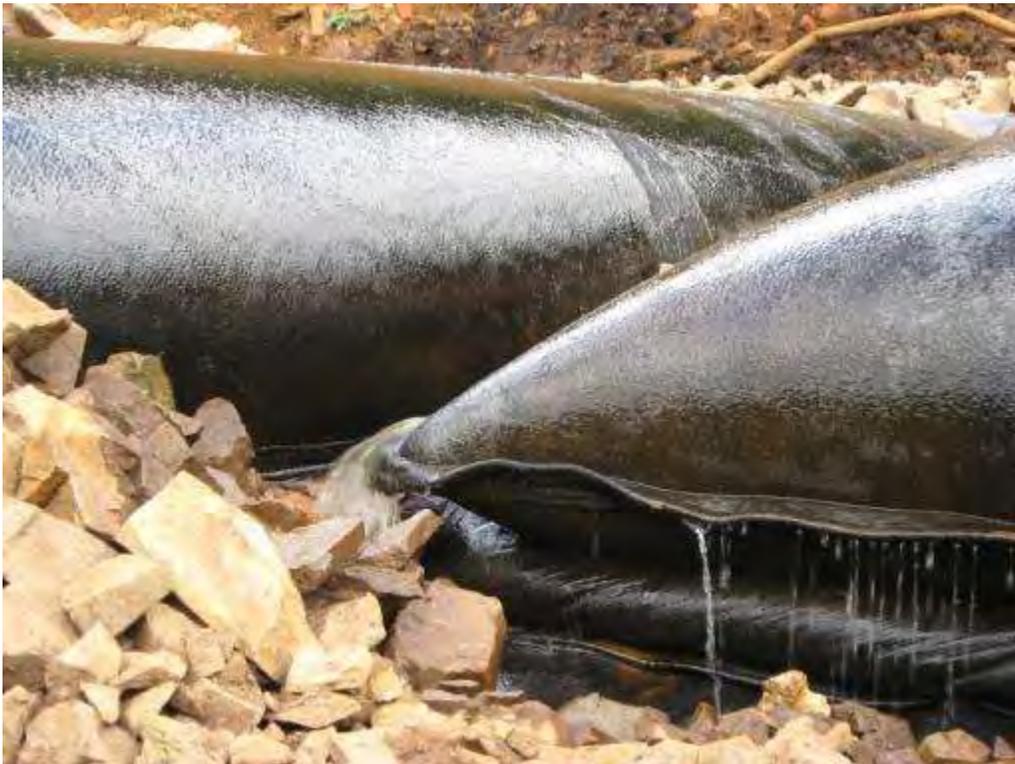
**PHOTO 26 9-13-2011**

Geotextile fabric water filtering bags passing filtered AMD water.

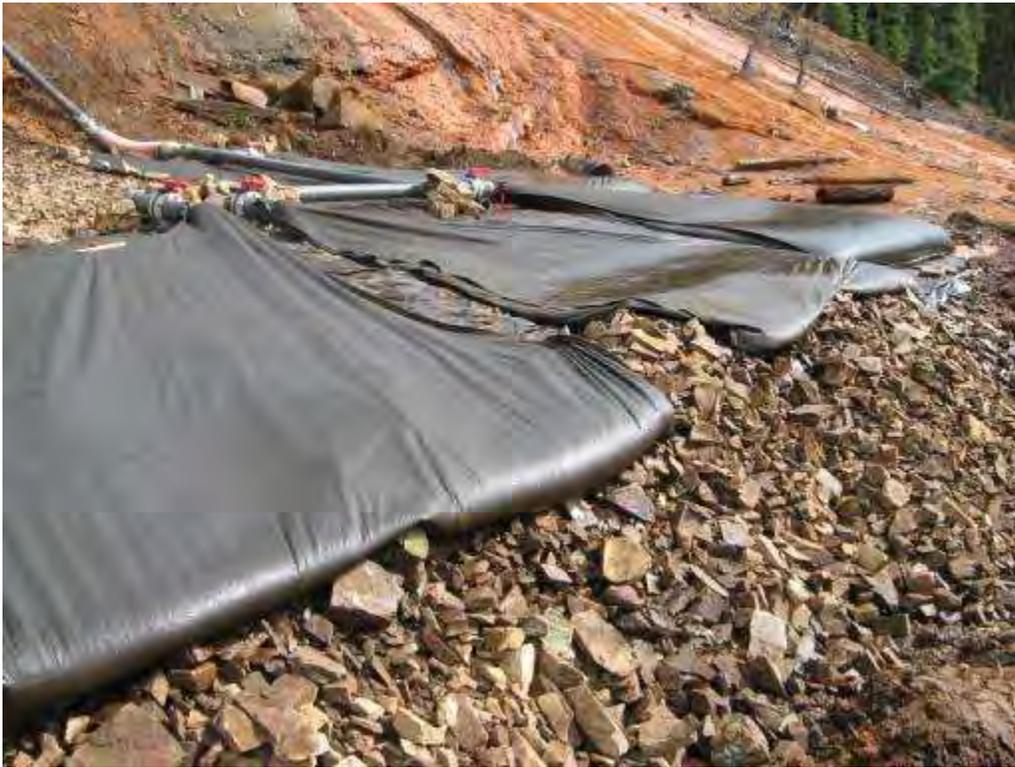
**PHOTO 27 9-11-2011**

Geotextile fabric filter bags at toe of mine dump slowly decanting after use.

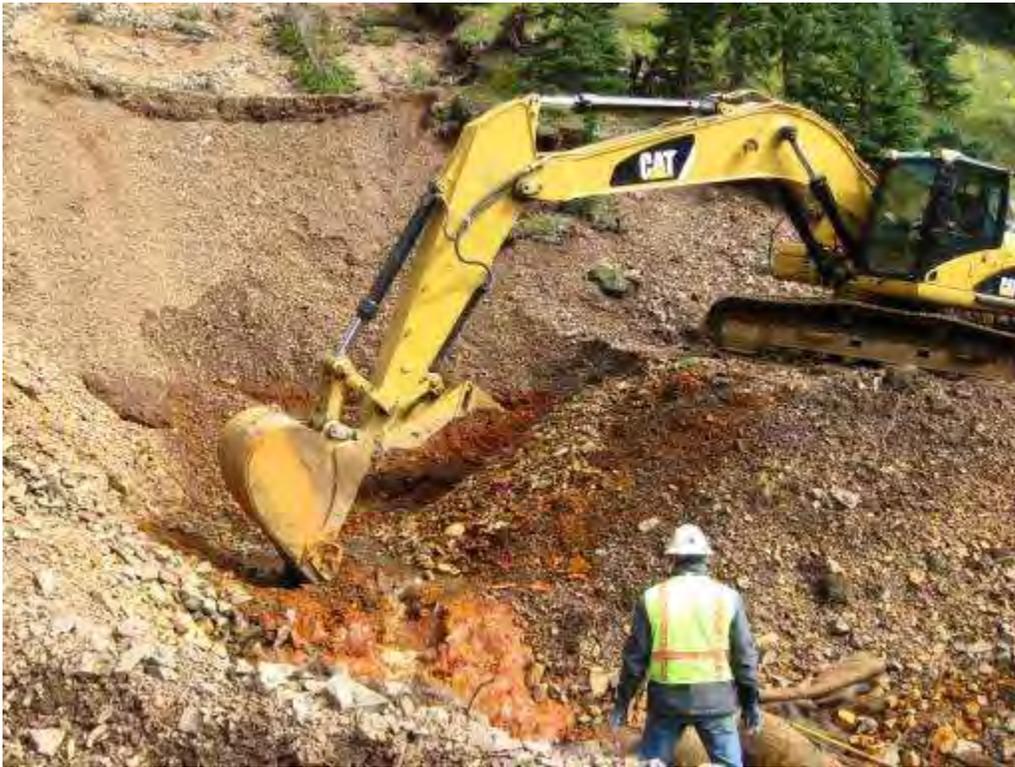
**PHOTO 31 9-13-2011**  
Excavation activities at collapsed portal.

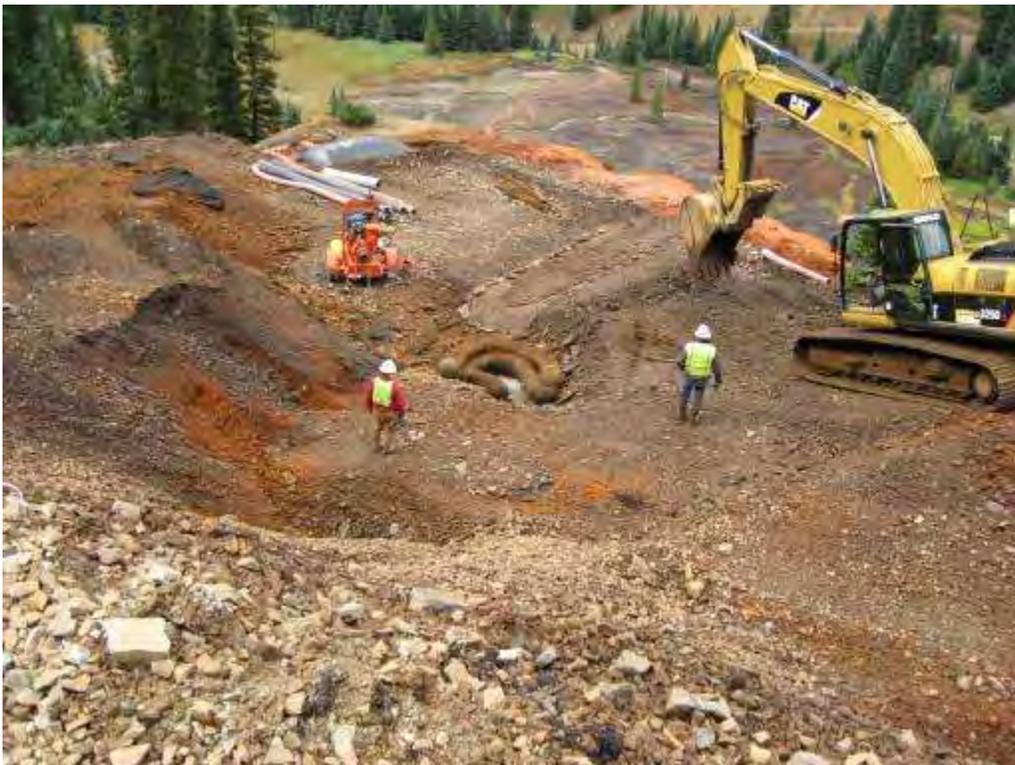
**PHOTO 32 9-15-2011**  
View of operations on top of dump. Collapsed portal behind nearest workman's back out of view in foreground, AMD water flowing through temporary rock dam (nearest workman standing on) to sump where Koir-Logs® are located, under-piped to geotextile filter bag in background (behind stacked piping) where water is filtered prior to release to the south ditch out of view. AMD water flows through stressed vegetation zone in photo background to Cement Creek.

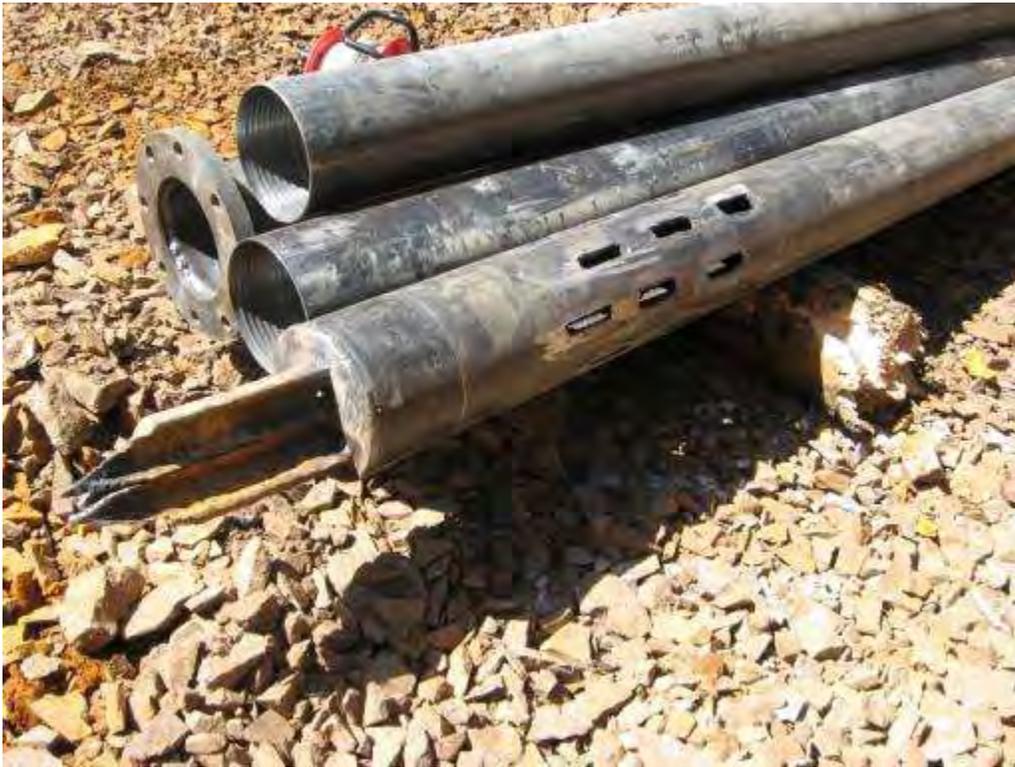
**PHOTO 33 9-22-2011**

Once the mine adit outline within competent rock was established by removal of much of the collapsed material, a 40-foot long, 6-inch diameter steel pipe was inserted into the mine adit through the remaining portal collapse (Photo 33). The pipe was used to pump water from the adit in order to reduce head pressure on the remaining portal collapse so additional excavation could be performed safely. The pumping rate through the pipe was monitored to gain insight regarding the potential of additional blockages inby of the mine portal by observing water extraction and recharge rates.

Schedule 40, 6.63-inch OD, flush-threaded steel pipe. Assembled during placement into mine adit. Used to pump AMD water from adit in controlled conditions.

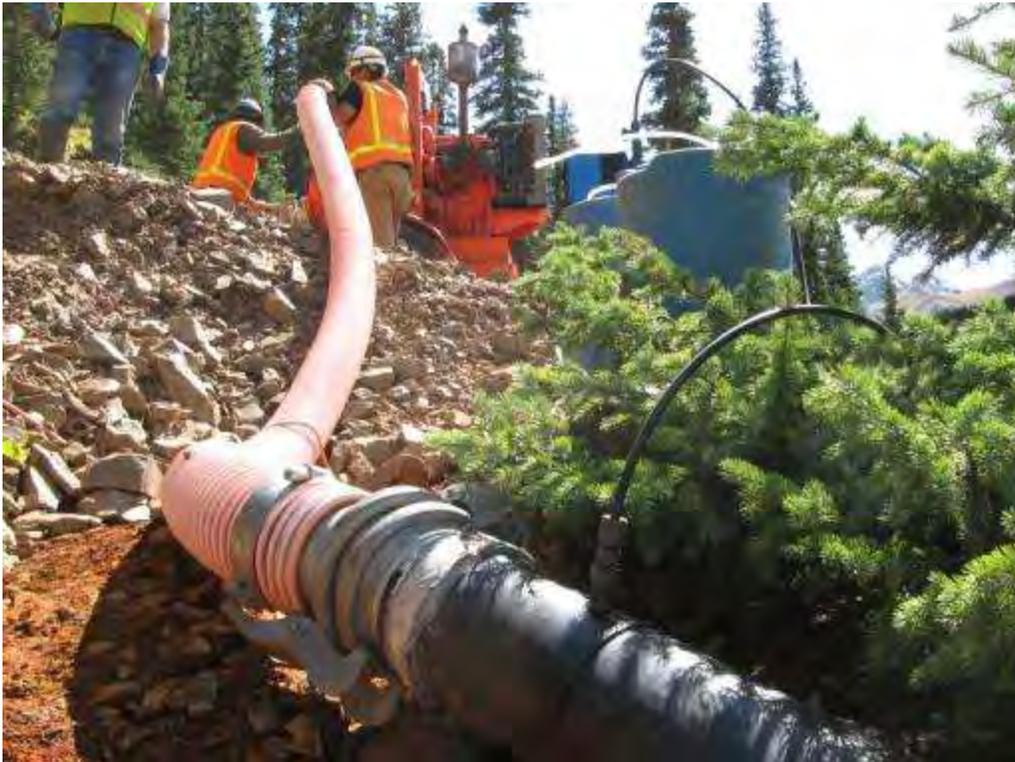
**PHOTO 34 9-22-2011**

Liquefied aluminum sulfate flocculent pumped from blue poly drums (photo right) into drain pipe directing flow to geotextile fabric filter bags located at dump toe.

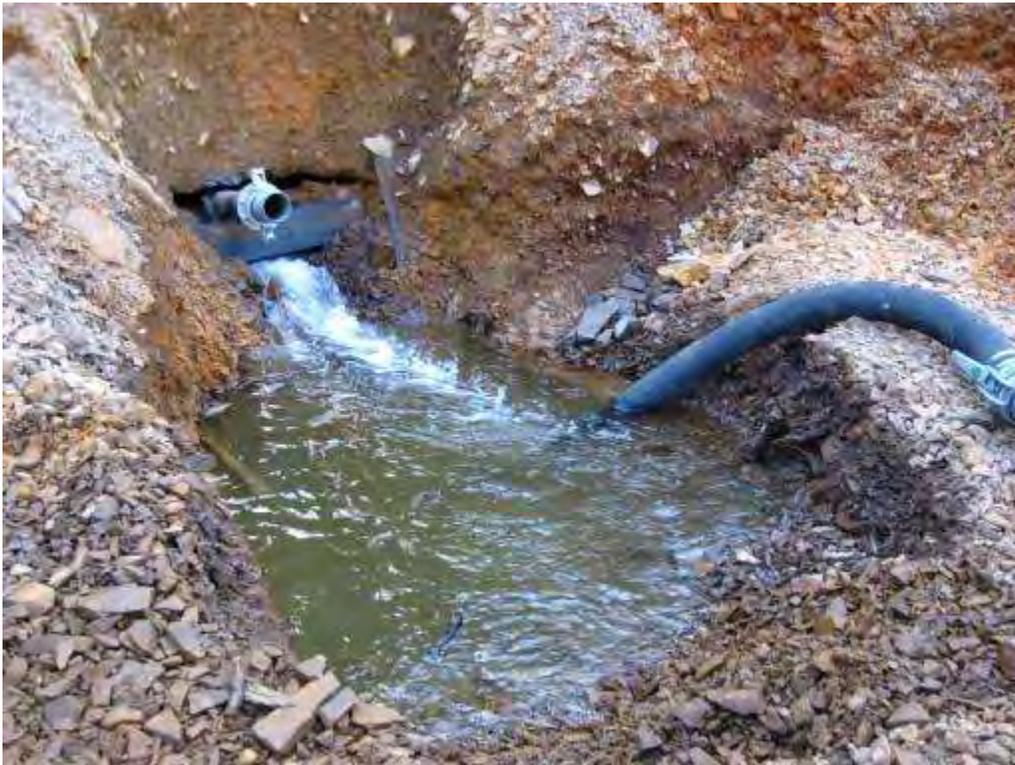
**PHOTO 35 9-27-2011**

Pumping water through hose from sump at excavated portal. Steel pipe placed in adit is visible resting on header above current collapse blockage.

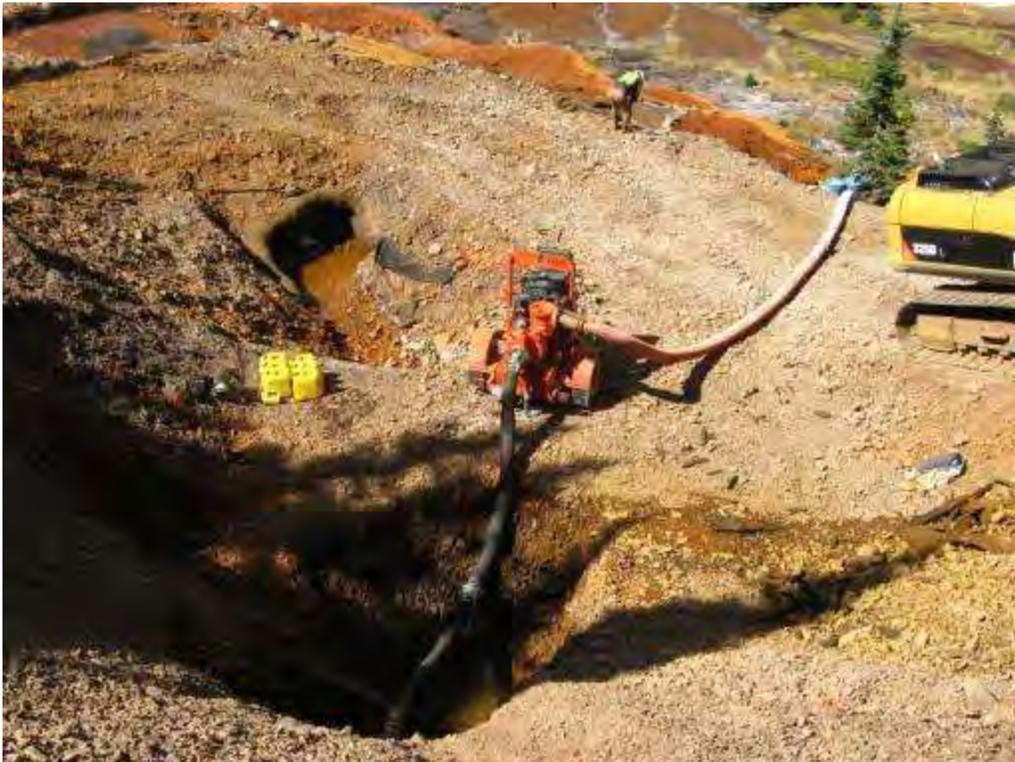
**PHOTO 36 9-27-2011**

AMD water pumping operations from steel pipe in adit. Water is piped to geotextile fabric filter bags located at toe of mine dump.
