## **FIELD ACTIVITIES REPORT Mine Adit Entry**

**RED AND BONITA MINE SITE  
Silverton, San Juan County, Colorado**

**TDD No. 1008-01**

**January 20, 2012**

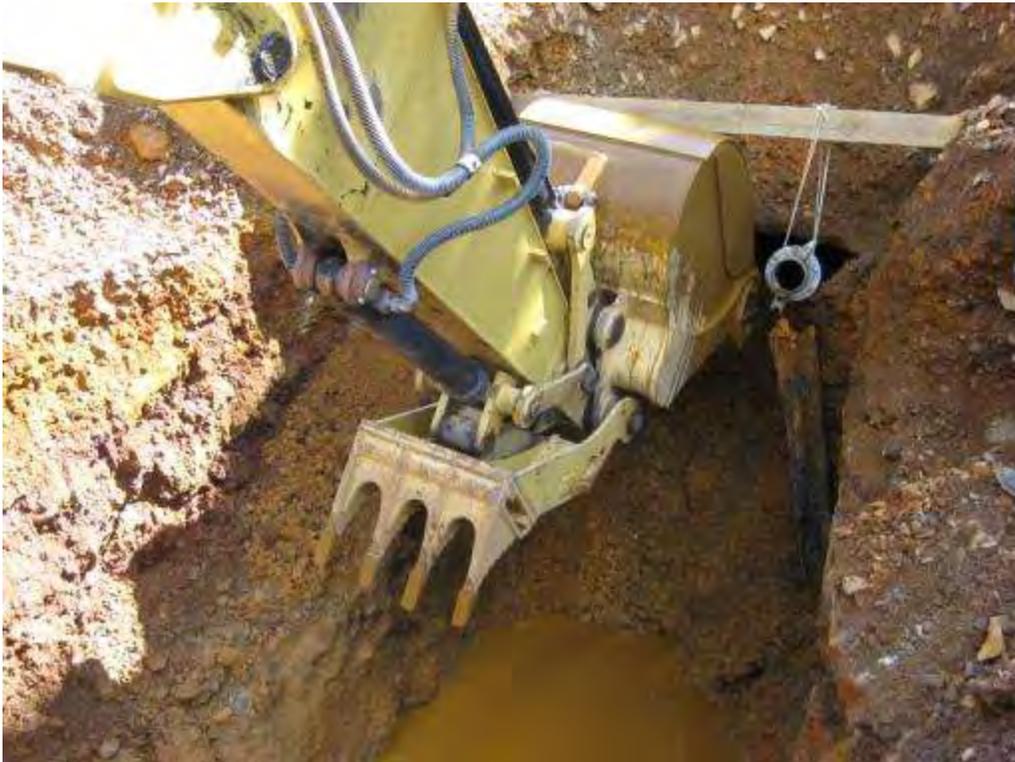
**PHOTO 38 9-29-2011**

Removing upper portion of remaining collapse material to allow AMD water to flow out of adit.

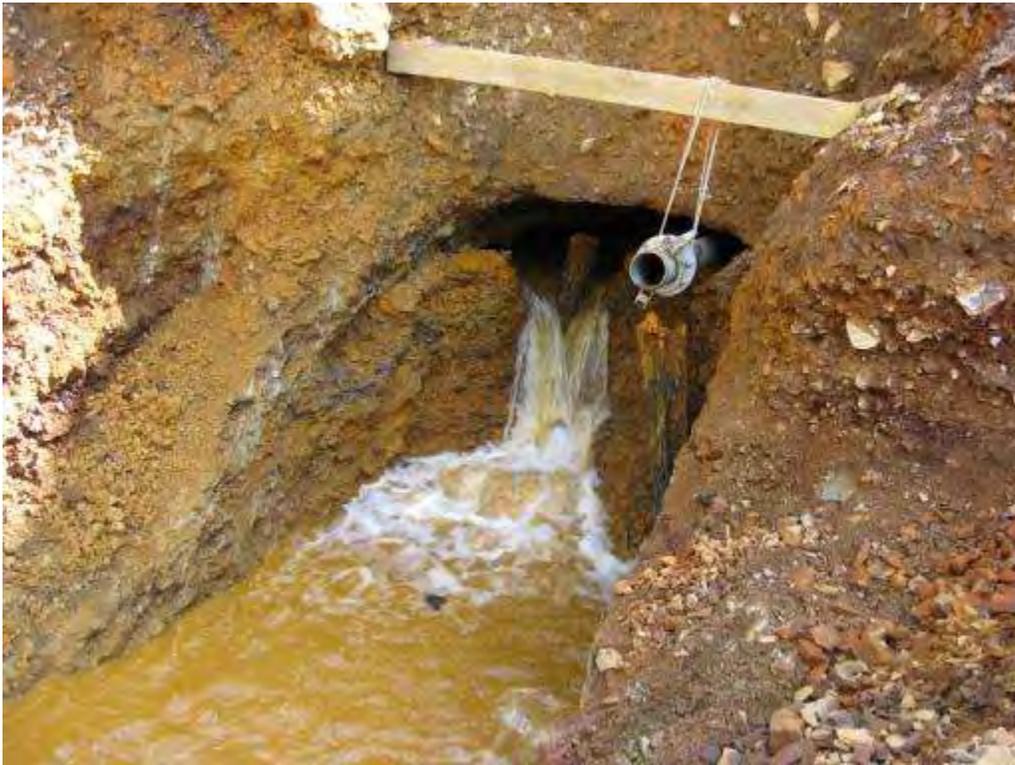
A ferricrete brow forming the top of the adit portal was readily distinguished and outward sloping ferricrete formed the sides of the adit in wedge shapes, apparently formed as the adit was cut into the sloping ferricrete formation (Photo 39). The ferricrete formation at the adit entrance appears to have formed at a slope angle similar to the existing mountainside slope. An approximate 2-foot thickness of material, mostly fines apparently transported by out-flowing AMD, was observed on

**PHOTO 39 9-29-2011**  
AMD water flowing from adit.

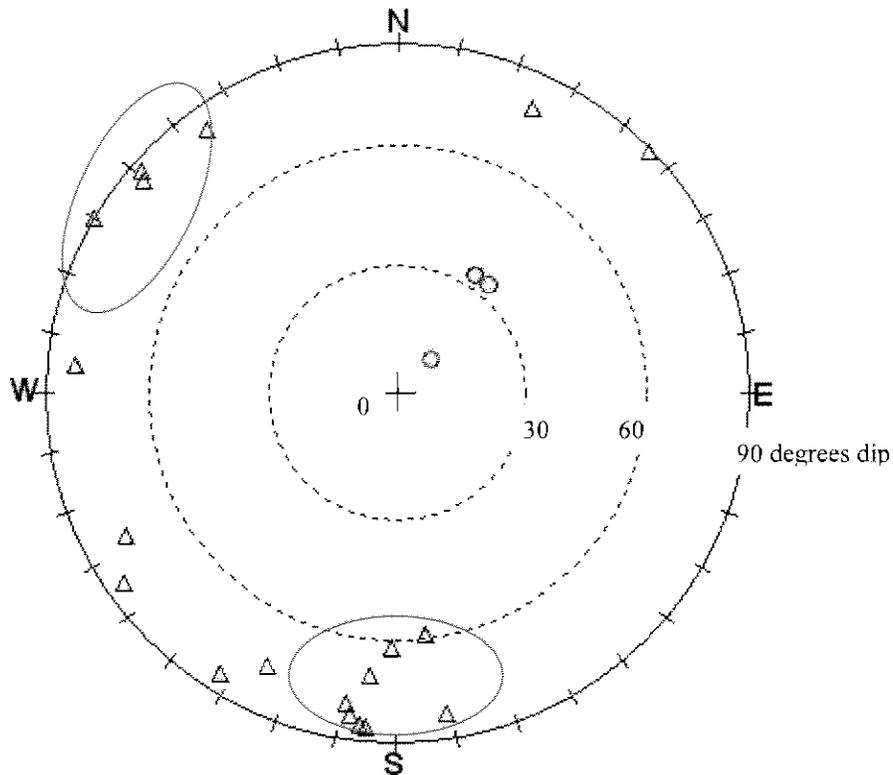
Figure 3. Pole plot of surface planar discontinuities measured around the Red & Bonita Workings. Triangles indicate poles of minor joints; circles indicate poles of flow laminations in andesite rock. The plot shows a cluster of poles to the south and a weaker set in the northwest sector, indicating two trends of anisotropy in the surface bedrock.

The southern pole cluster represents a set of joints trending roughly east-west, with dips of 60 to 89 degrees to the north. The northwest pole cluster represents joints striking roughly northeast-southwest, dipping steeply southeast. These orientations are similar to the dominant northeast-southwest anisotropy noted in the Simon Hydrosearch report prepared for the Sunnyside Mine (Stock, et. al, 1992,1993). They reported permeability greater in a northeast-southwest direction due to the dominant fracture orientation within this section of the Eureka Graben. The structural discontinuities measured in this study tend to agree with the direction of structural anisotropy as shown on published geologic maps and reports for this area near the Eureka Graben. Flow structure (crude bedding) in the andesite strikes south-east and dips gently southwest.

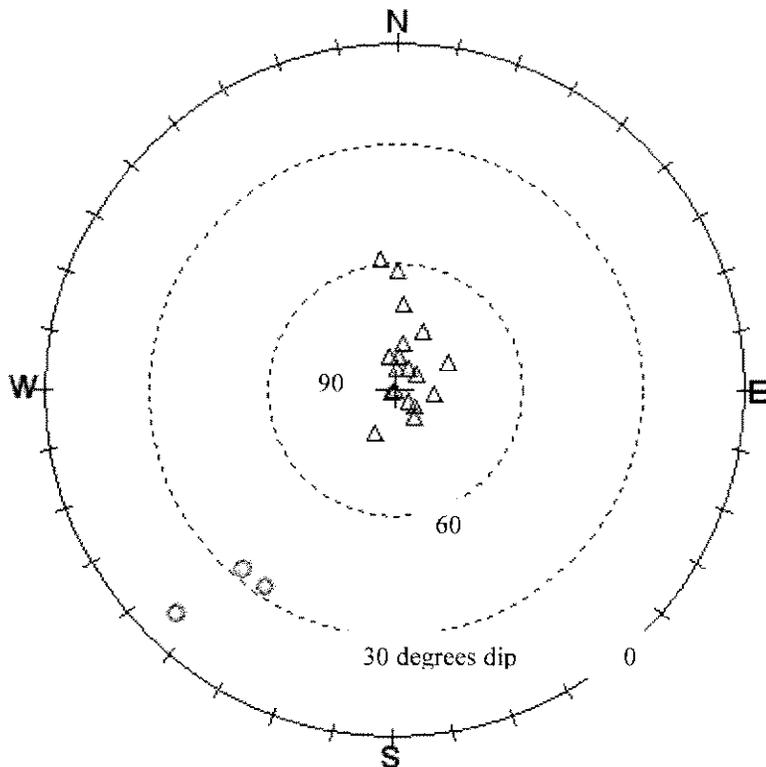
Figure 4. Dip vector plot for planar discontinuities measured on surface around the Red & Bonita workings. Triangles indicate dip of minor joints; circles indicate dips of flow laminations in andesite rock. Most joints are steeply dipping, while flow structure has shallow dips.

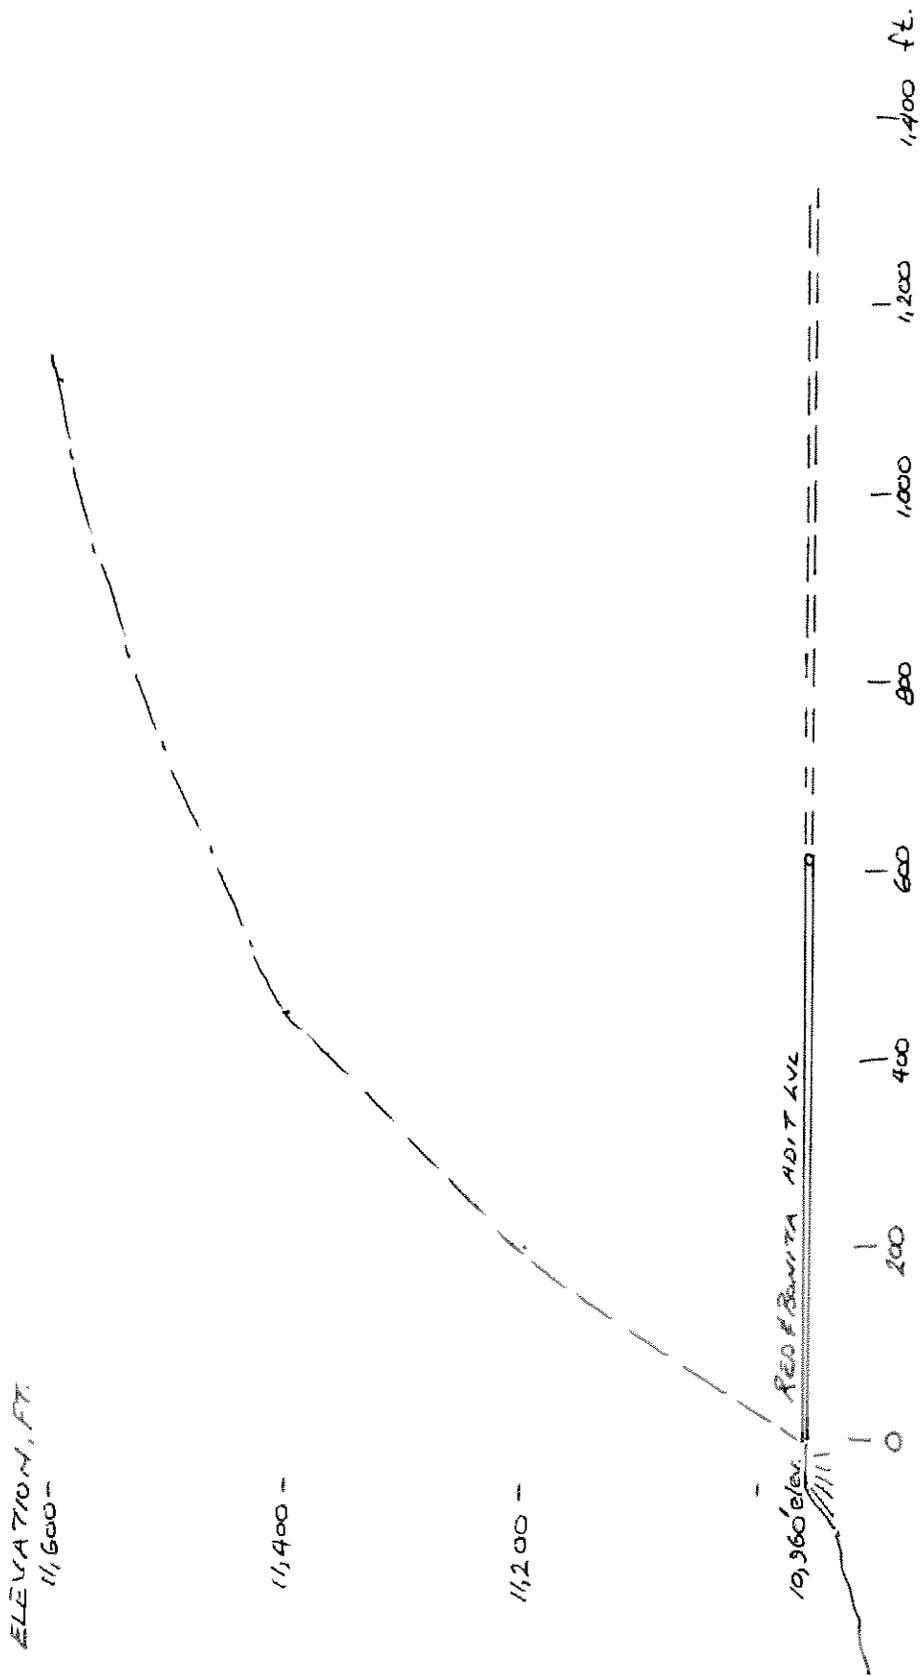
FIGURE 6. DEPTH OF COVER PROFILE ABOVE RED BENITA ADIT

A preliminary cross section along the R&B workings was constructed as part of the bulkhead feasibility consideration (Figure 6). Due to the extremely steep valley walls along Cement Creek there are 400 feet of overburden at 400 feet in from the portal, and 600 feet of depth at 1,000 feet from the portal. A final bulkhead design must take into account the expected pressure head and depth of overburden available to prevent hydro-fracturing of the rock around the bulkhead. In the case of the R&B workings, it appears that sufficient cover exists to continue consideration of a bulkhead if this approach is chosen.

DEPTH OF COVER  
(VERTICAL EXAGGERATION)

3. The location of any bulkhead should be as far back from the portal and shallow fractured rock aquifer as possible, while avoiding the altered rock zones adjacent to mineralized veins. A thorough investigation of formation permeability at selected plug locations should be included in any underground investigations. This will determine the formation (curtain) grouting needed to seal the rock around the bulkhead. If the bulkhead is placed too close to surface, a great deal more grouting will be required to isolate the impounded water from communicating with the near-surface fractured rock aquifer, and there is a higher degree of risk that water will find a pathway around the bulkhead.
